**City Council/Enterprise Boards**  
**TOWN HALL MEETING**  
**AGENDA**  
Tuesday, July 13, 2021  
6:30 PM  
130 South McKinley Avenue

Thank you for taking time to meet with us last week and explaining the options the City offers local businesses for resolving issues. We are representing Mahnke Auto Body on 540 Main Street, Fort Lupton, Colorado. Attached to this document are photos of Sixth Street, Fort Lupton, the single block which runs on the north side of the building, in front of the shop.

The following five pictures were taken September 10th, 2020 before the contractor's work. Looking east on Sixth Street, Mahnke Auto Body is on the right.

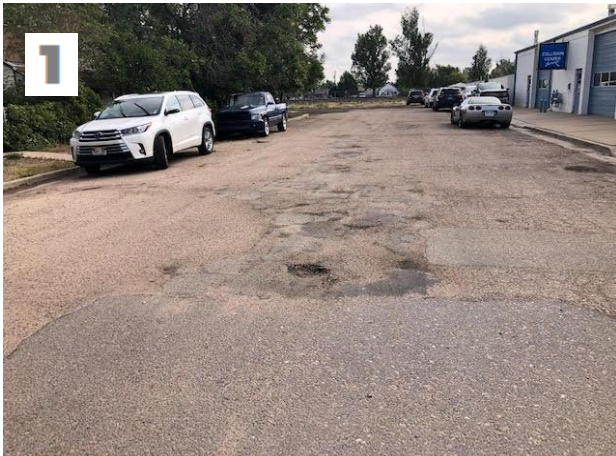
**1.**  
**540 Main Street, Fort Lupton**  
**Sixth Street Shop Frontage**

Example of alligating, cracked and uneven road surface. View is from intersection at Main Street and Sixth Street looking east to dead end at railroad tracks.

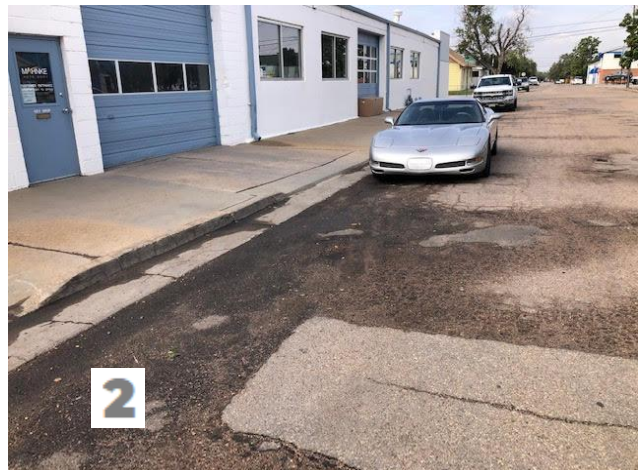
**2.** Looking east on Sixth Street toward Main Street. The blue overhead doors go into Mahnke's work bays.

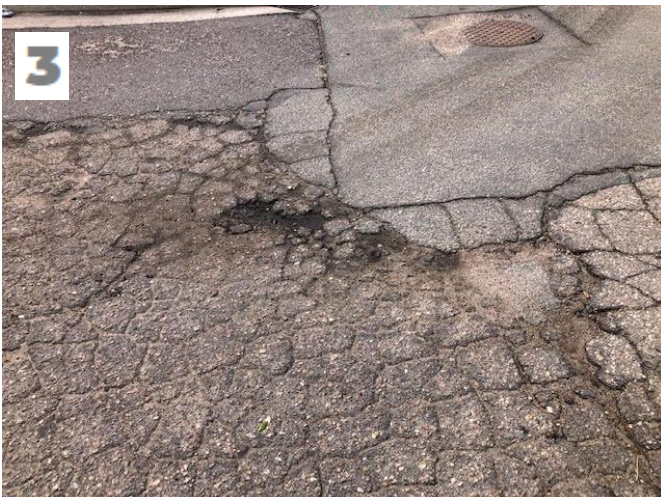
**3.** Close up of alligating, cracks, and disrepair on Sixth Street.

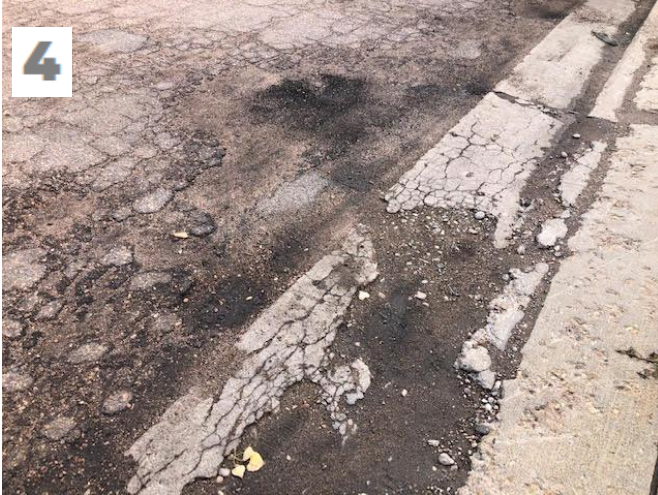
4. The damaged street gutter in front of Mahnke's work bay on Sixth Street.

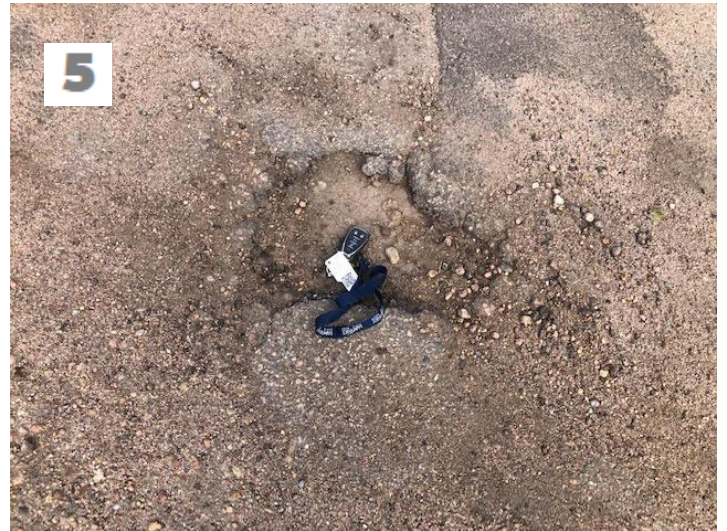
5. Another deep pothole on Sixth Street (Car keys in hole for scale)

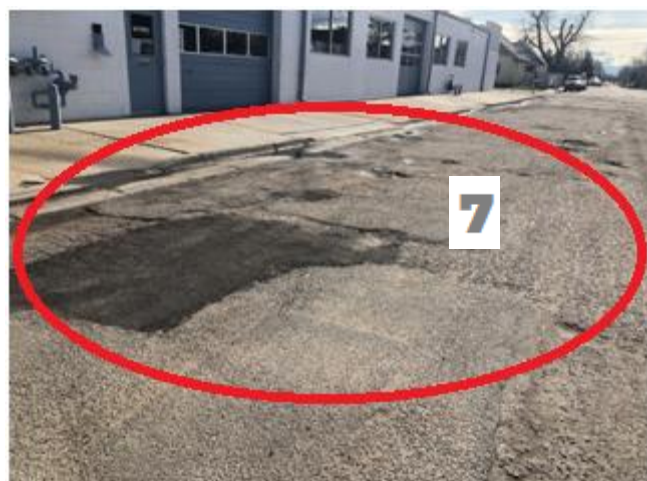
7. This picture shows the majority of the patchwork the contractor completed on Sixth Street, facing west.

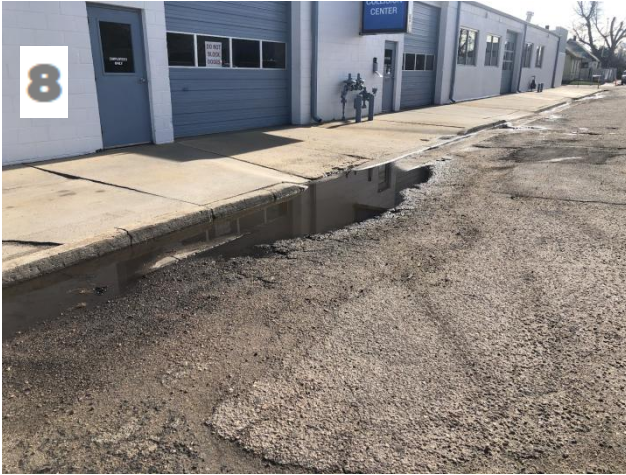
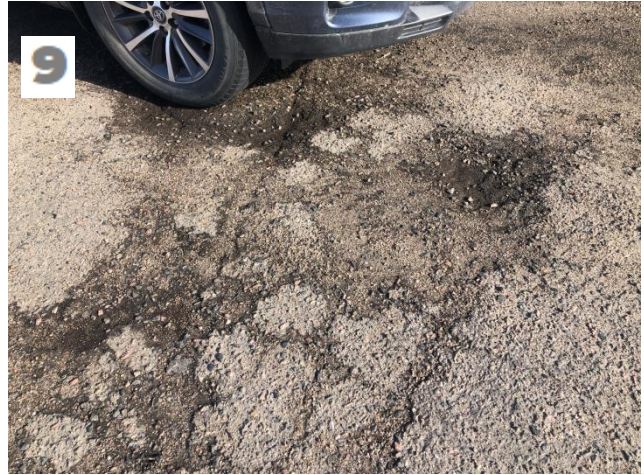
8. The road is still in terrible shape after the Contractor's work. There was standing water from snowmelt pooling in the severely damaged pavement which freeze creating a hazardous conditions for Mahnke's customers, pedestrians, and employees, in addition to hastening the deterioration of the street.

9. Employees have been successful navigating customer's vehicles over this rough road and helping customers cross over dangerous ice and snow. Mahnke accepts its responsibility to provide safe access to and from the building at all times.

Mahnke respectfully requests the City to properly repair this block of Sixth street.

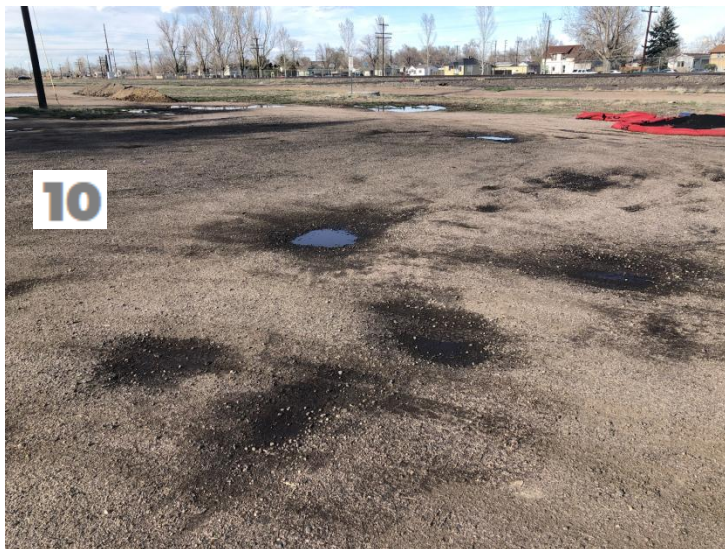
10. This is at the dead end of Sixth Street, facing east toward the Railroad Tracks.

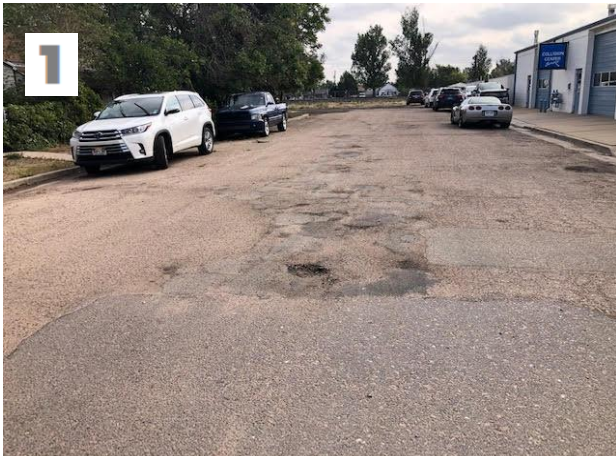
**1.**  
**540 Main Street, Fort Lupton**  
**Sixth Street Shop Frontage**

Example of alligating, cracked and uneven road surface. View is from intersection at Main Street and Sixth Street looking east to dead end at railroad tracks.

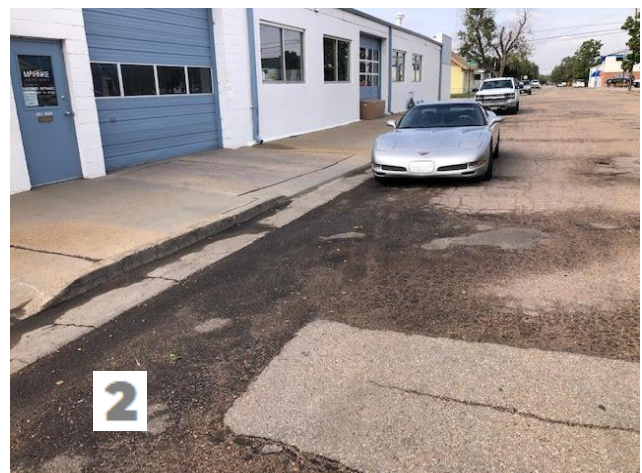
**2.** Looking east on Sixth Street toward Main Street. The blue overhead doors go into Mahnke's work bays.

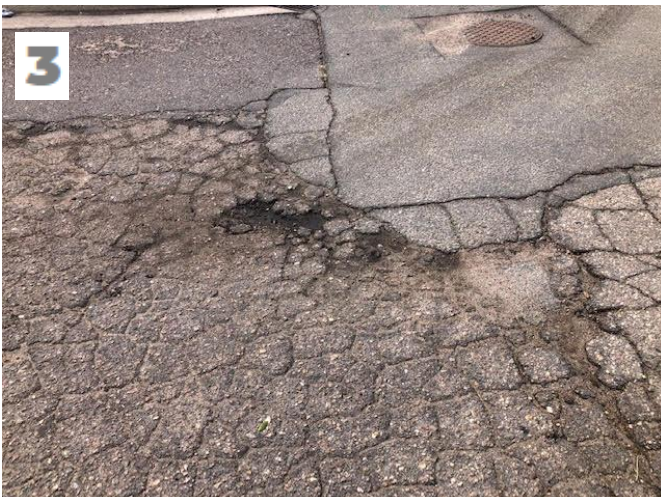
**3.** Close up of alligating, cracks, and disrepair on Sixth Street.

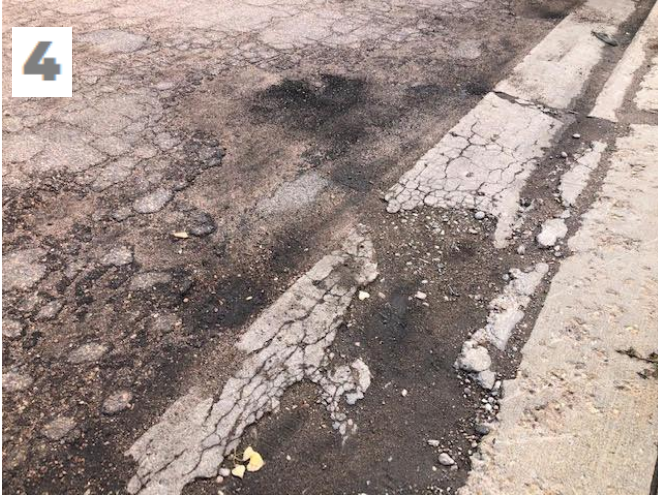
4. The damaged street gutter in front of Mahnke's work bay on Sixth Street.

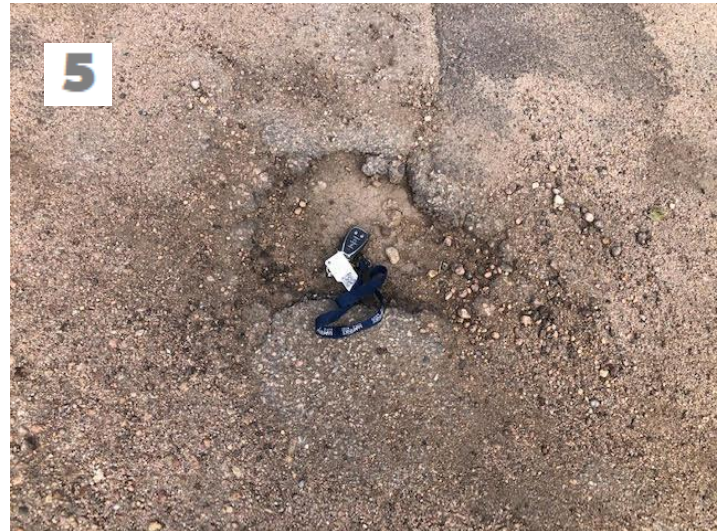
5. Another deep pothole on Sixth Street (Car keys in hole for scale)

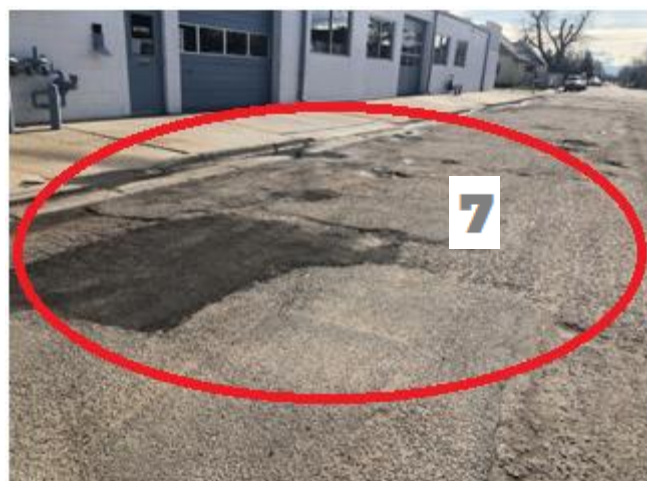
7. This picture shows the majority of the patchwork the contractor completed on Sixth Street, facing west.

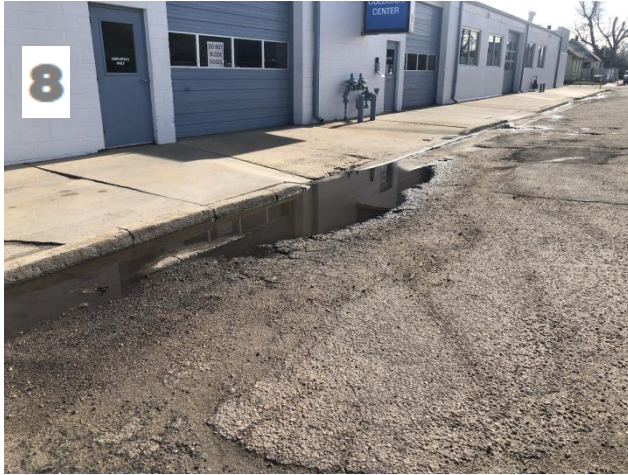
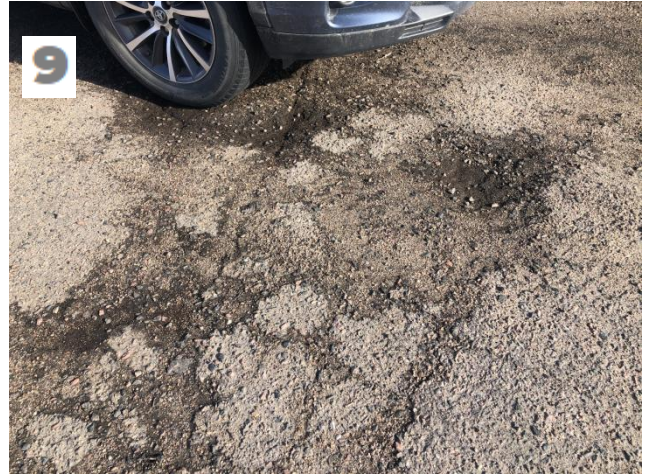
8. The road is still in terrible shape after the Contractor's work. There was standing water from snowmelt pooling in the severely damaged pavement which freeze creating a hazardous conditions for Mahnke's customers, pedestrians, and employees, in addition to hastening the deterioration of the street.

9. Employees have been successful navigating customer's vehicles over this rough road and helping customers cross over dangerous ice and snow. Mahnke accepts its responsibility to provide safe access to and from the building at all times.

Mahnke respectfully requests the City to properly repair this block of Sixth street.

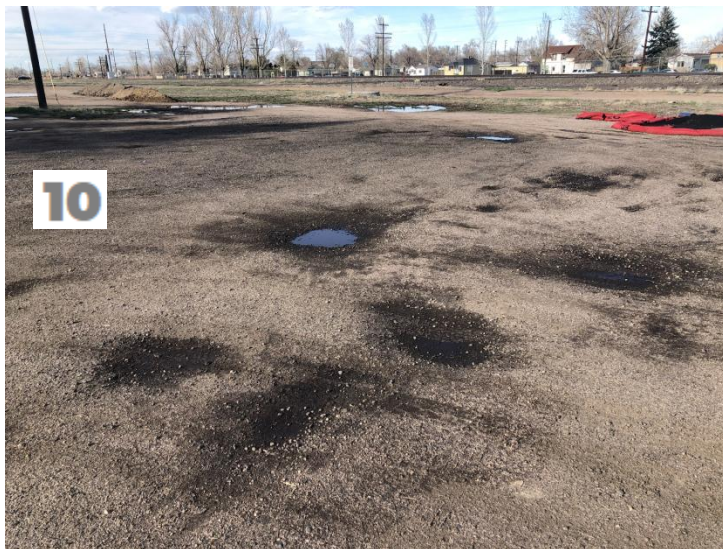
10. This is at the dead end of Sixth Street, facing east toward the Railroad Tracks.
