**Historic Preservation Board Agenda  
Regular Meeting\***  
**Virtual Meeting via GoToMeeting**  
**Thursday, April 1, 2021 – 6:15 P.M.**  
*(Order & Contents Subject to Change by Action of the Historic Board)*

**CONSIDER AN APPLICATION FOR RESCISSION OF LOCAL HISTORIC DESIGNATION OF THE SEYMOUR AND BIRDIE RHODE HOUSE LOCATED AT 149 DENVER AVENUE AND PROVIDE A RECOMMENDATION TO THE FORT LUPTON CITY COUNCIL**

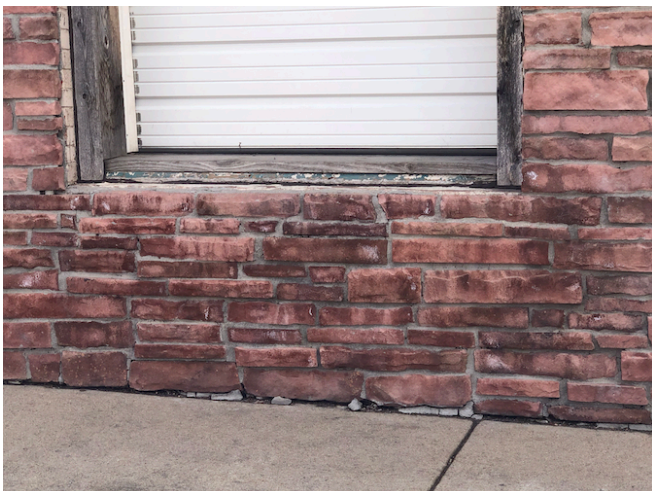
Ugly pink, fake flagstone & water damage

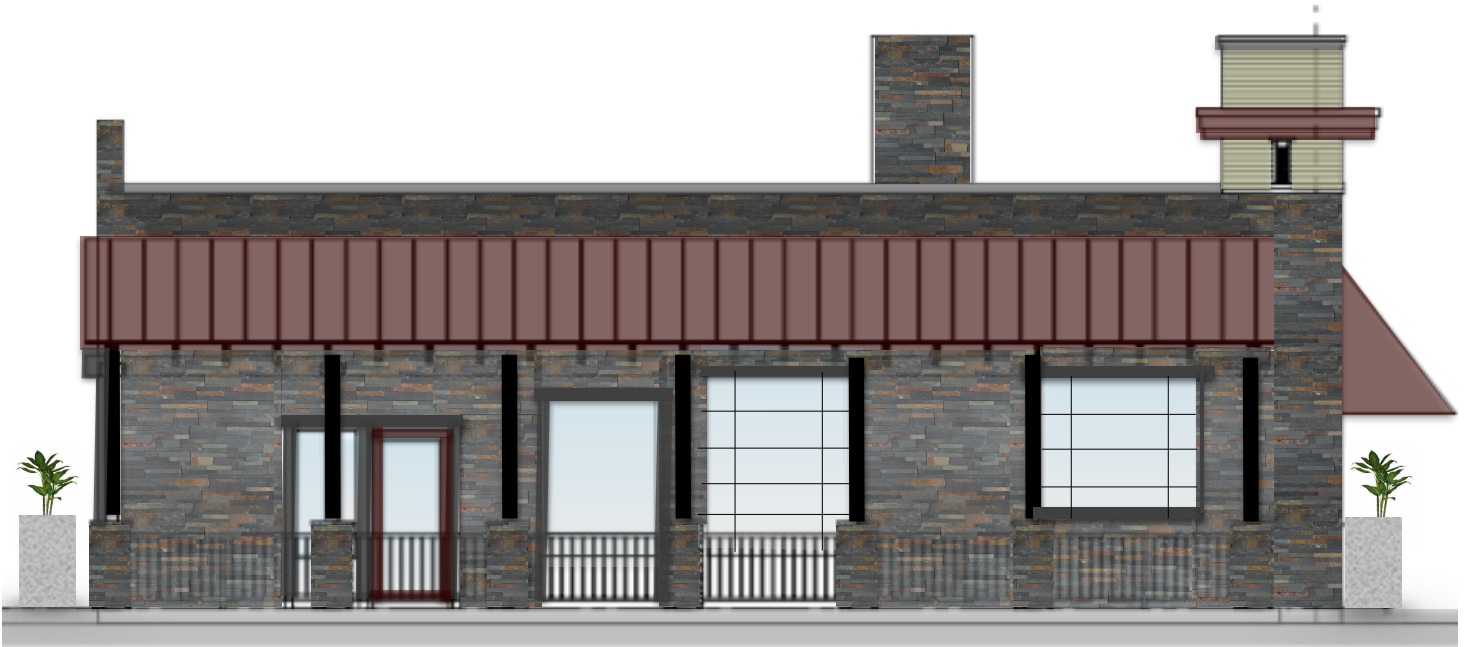
**NORTH PATIO ELEVATION**

The patio's floor will be a stamped and stained concrete with a hardwood floor pattern. The patio will be lit with string lights inside the covered area and small barn lights on the perimeter which match the existing barn lights on the St John.

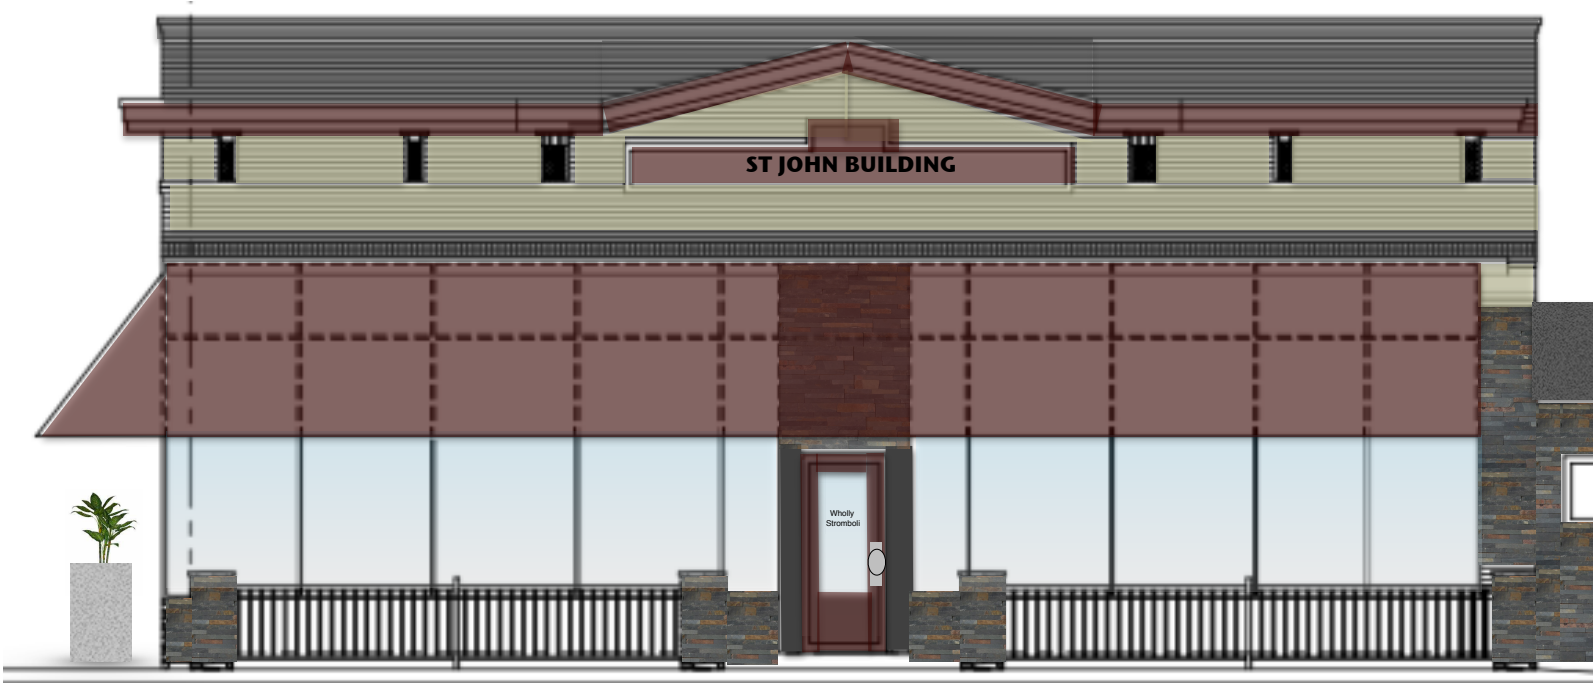
**SOUTH NEW MAIN ENTRANCE ELEVATION**

The entrance to Wholly Stromboli will move to the original - South entrance of the building. We will create a small patio in the area between our building and the city sidewalk. The St John sign will be painted bronze and the lettering just slightly darker in color so that it will stand out. The painted brick above the cornice will be painted grey. We will replace the store front door with a historic wooden front door as pictured below.

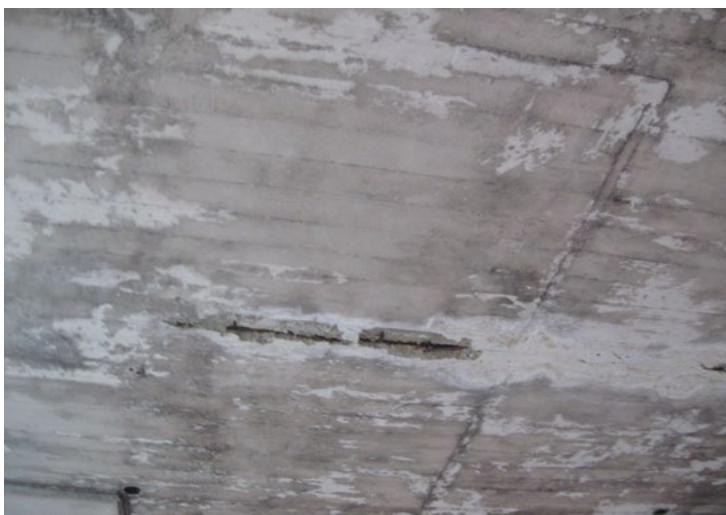
[5] Rebars in the reinforced concrete ceiling have rusted, causing the concrete to spall. The rebars must be cleaned of rust before the concrete can be patched.

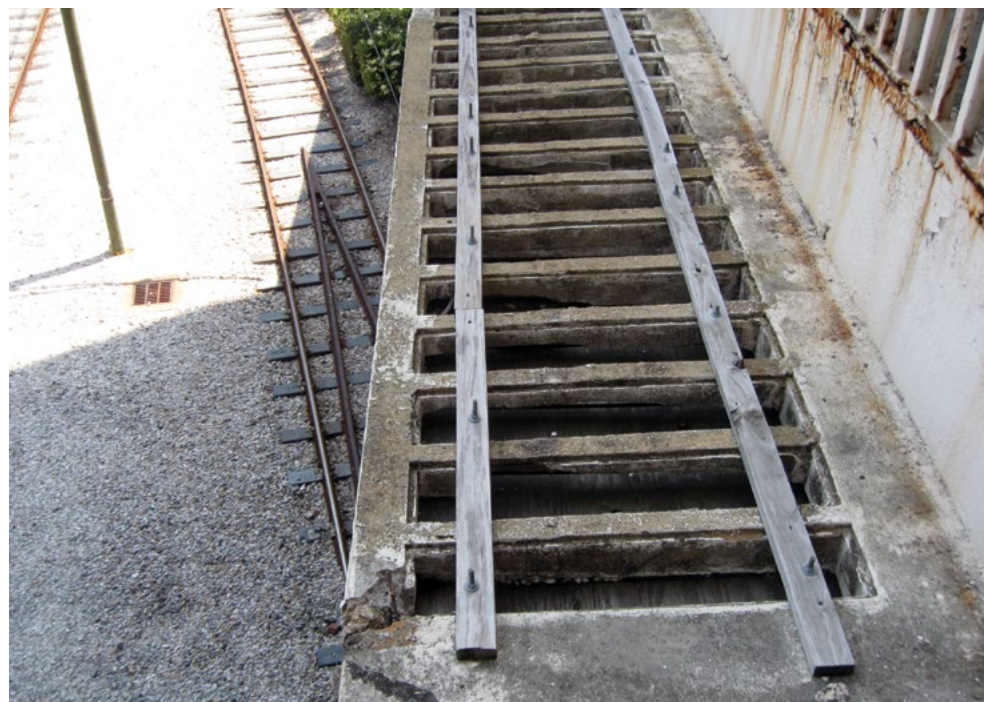
[6] Some areas of the concrete brise soleil screen on this building constructed in 1967 are badly deteriorated. If the screen cannot be repaired, it may be replaced in kind or with a composite substitute material with the same appearance as the concrete.

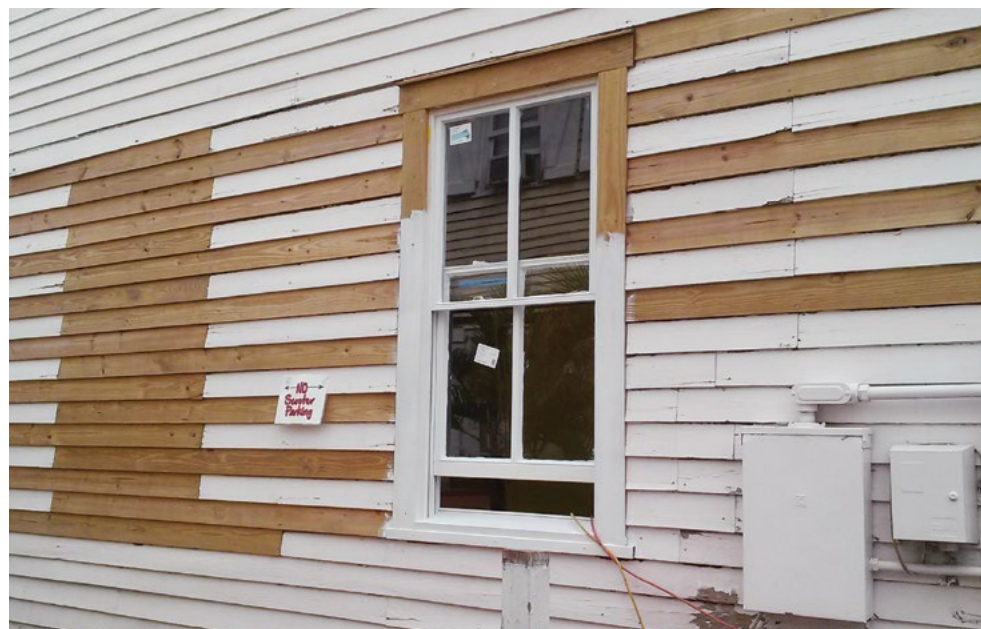
[8] Rotted clapboards have been replaced selectively with new wood siding to match the originals.

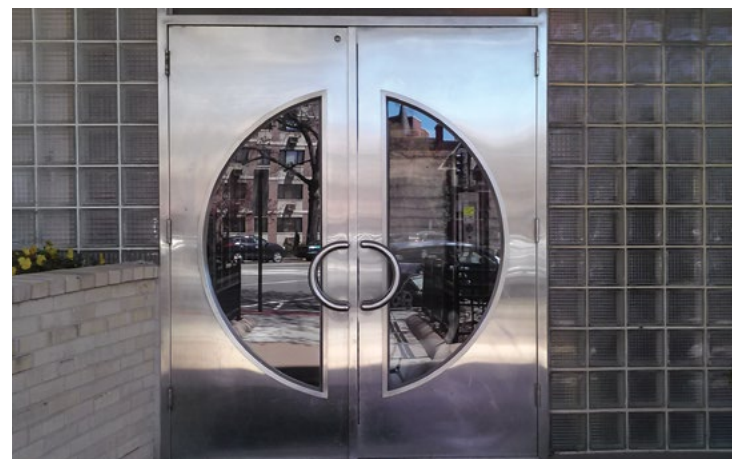
[11] The stainless steel doors at the entrance to this Art Deco apartment building are important in defining its historic character and should be retained in place.

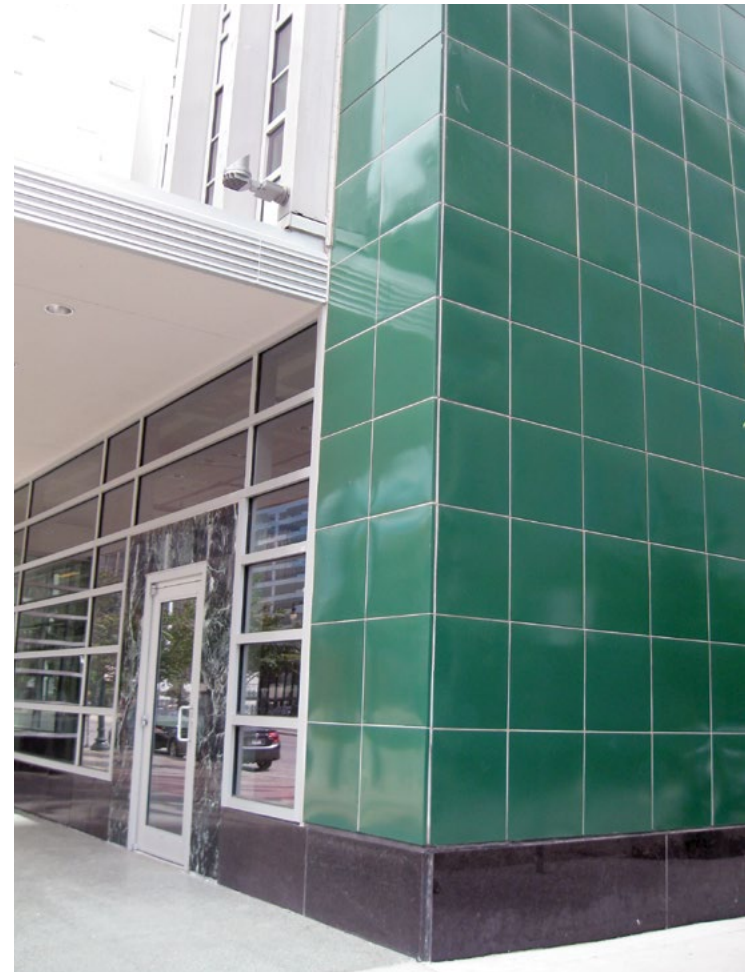
[15] New enameled-metal panels were replicated to replace the original panels, which were too deteriorated to repair, when the storefront of this early 1950s building was recreated.

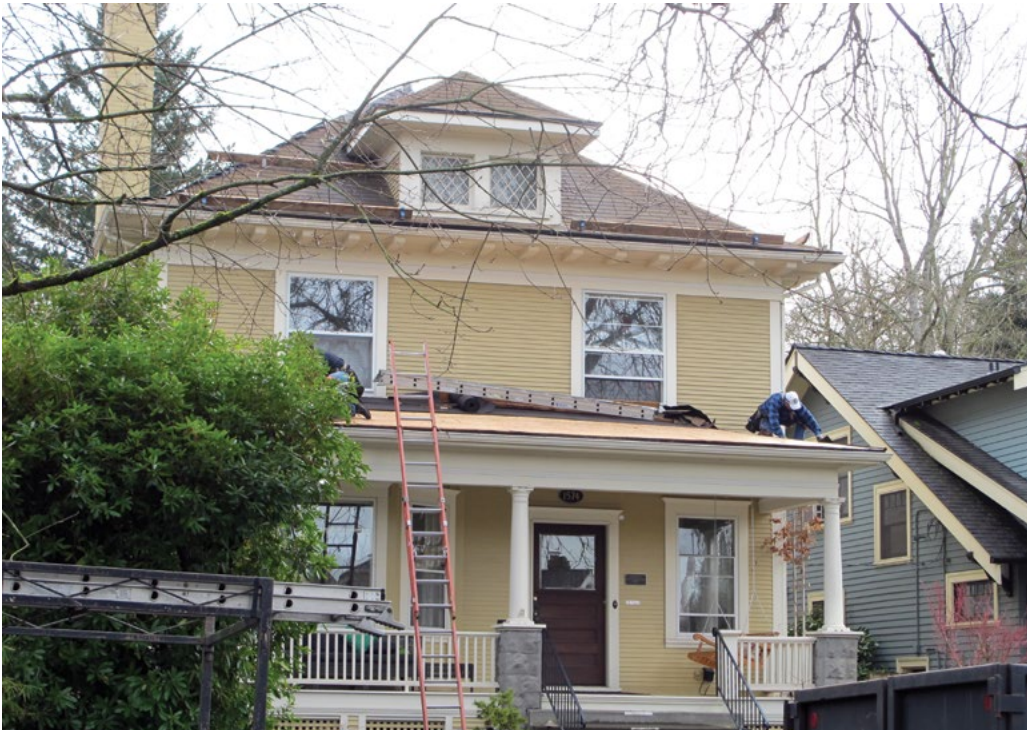
[16] The deteriorated asphalt shingles of this porch roof are being replaced in kind with matching shingles.

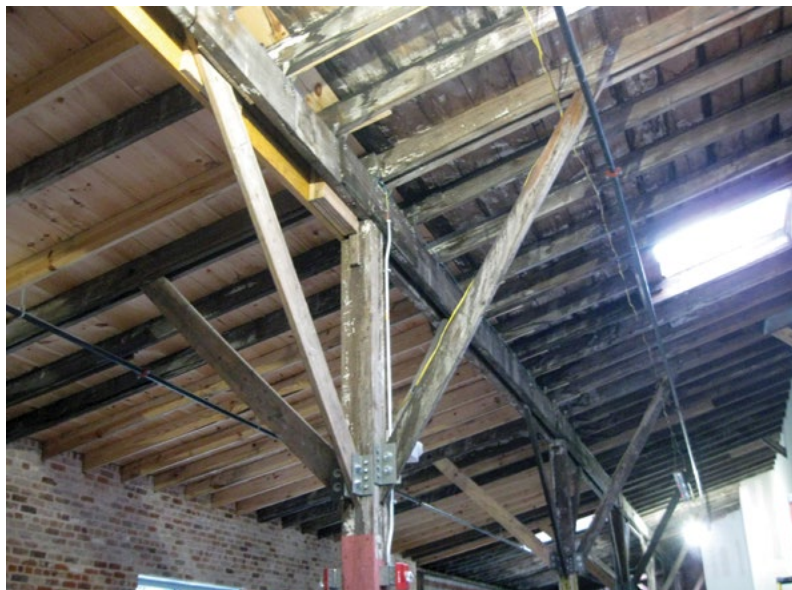
[17] New wood elements have been used selectively to replace rotted wood on the underside of the roof in this historic warehouse.

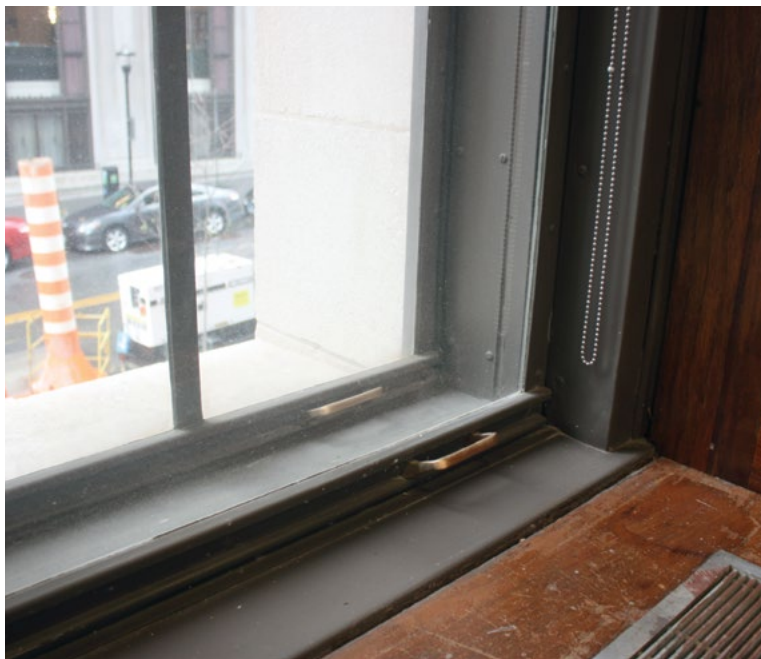
[18] The historic metal storm windows in this 1920s office building were retained and repaired during the rehabilitation project.

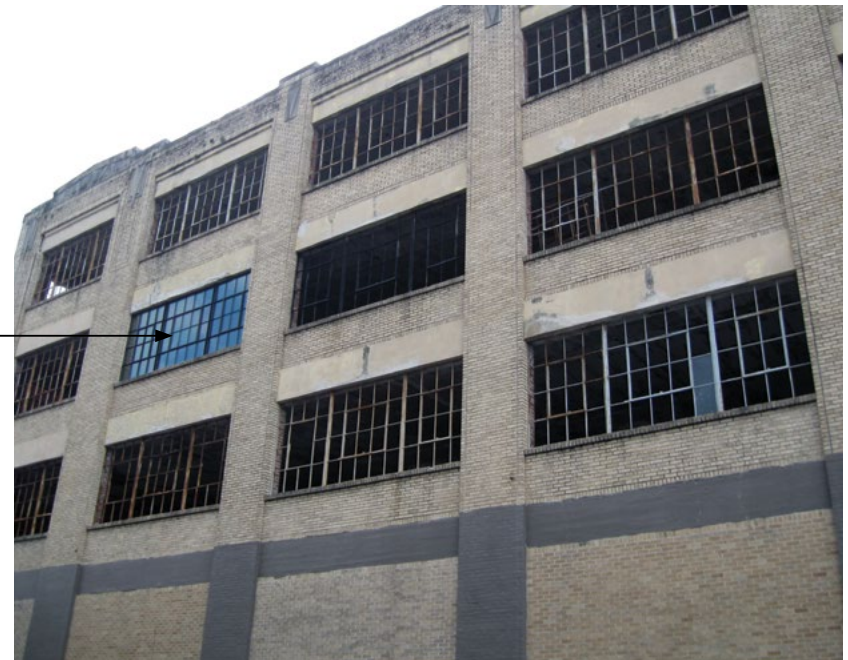
[19] Installing a mockup of a proposed replacement window can be helpful to evaluate how well the new windows will match the historic windows that are missing or too deteriorated to repair.

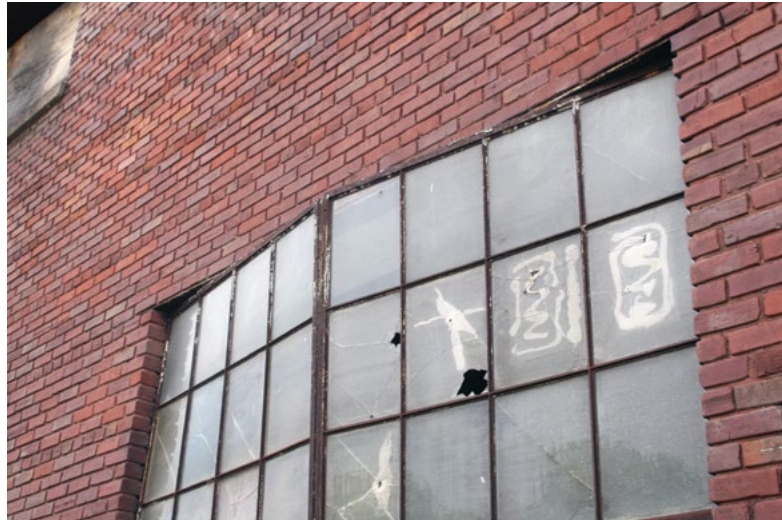
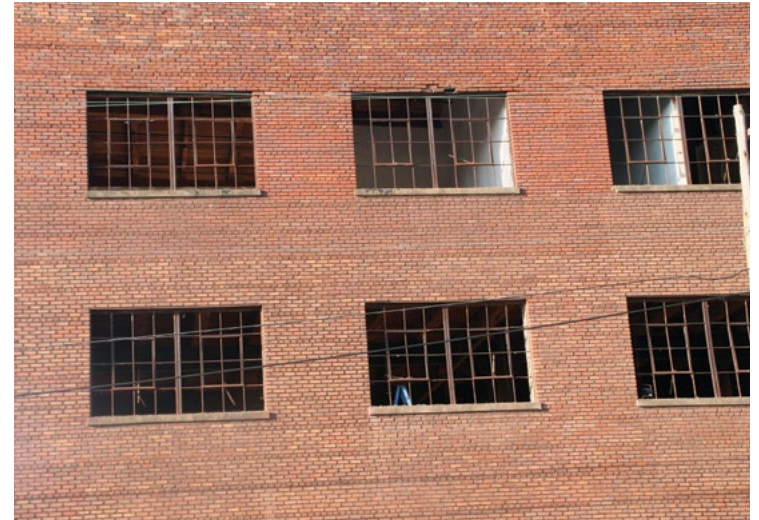
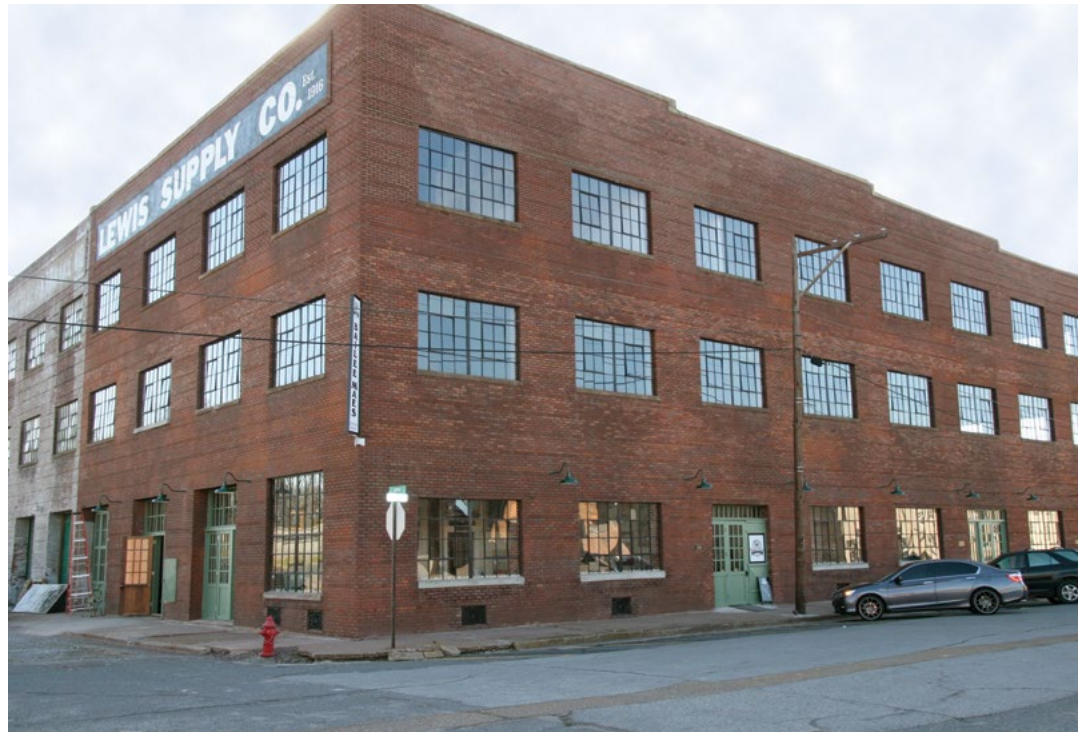
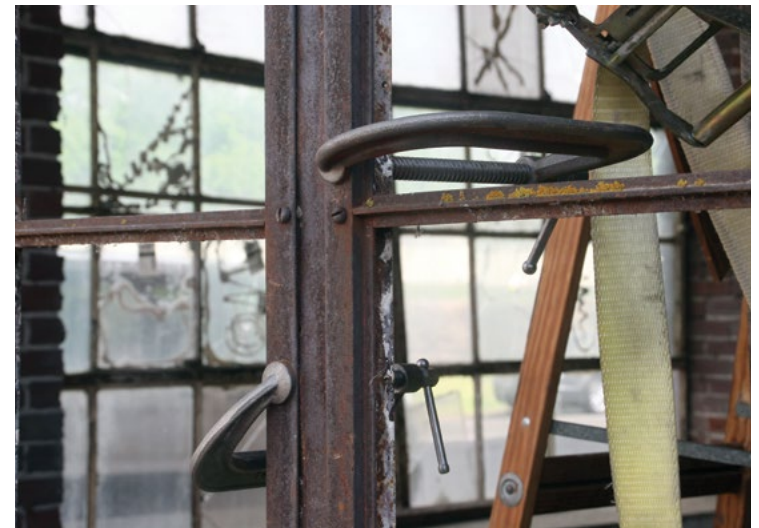
[20 a-d] The original steel windows in this industrial building were successfully repaired as part of the rehabilitation project (left).

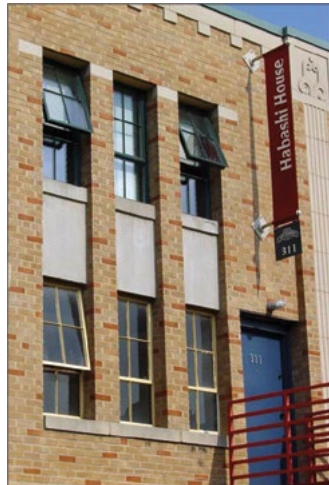
[21] The windows on the lower floor, which were too deteriorated to repair, were replaced with new steel windows matching the upper-floor historic windows that were retained.

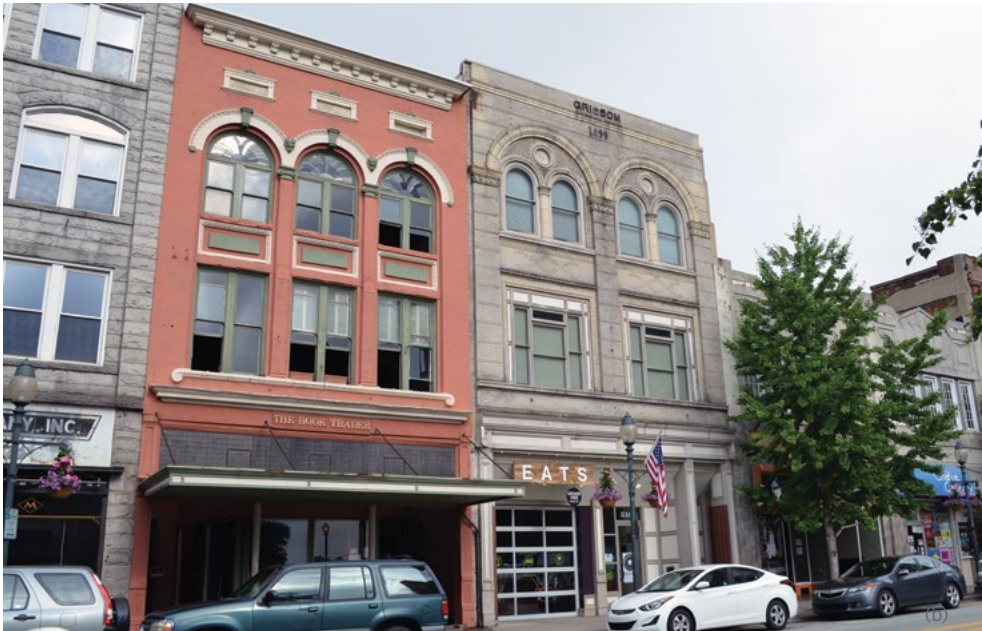
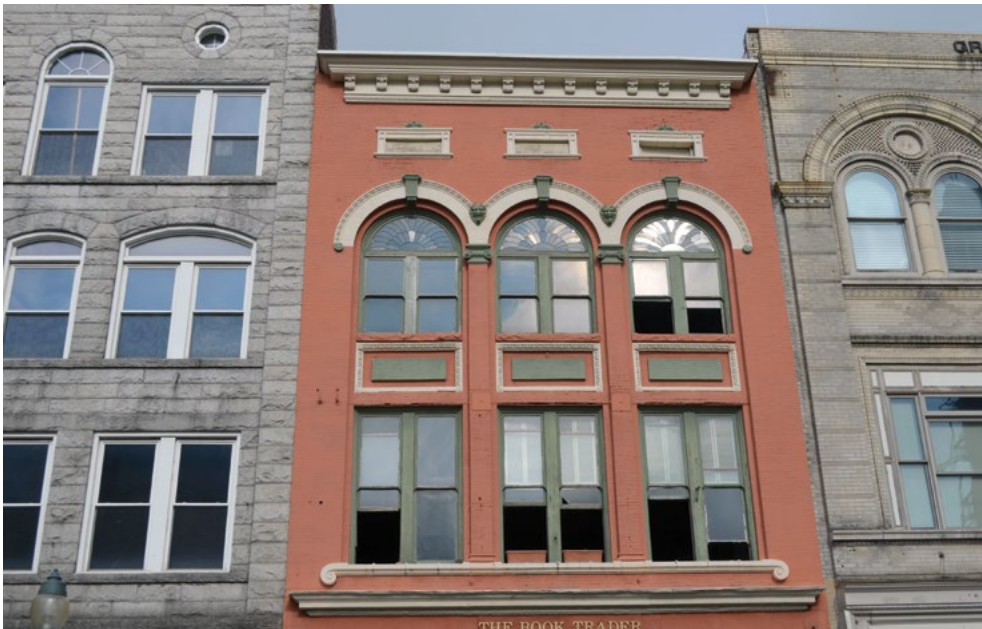
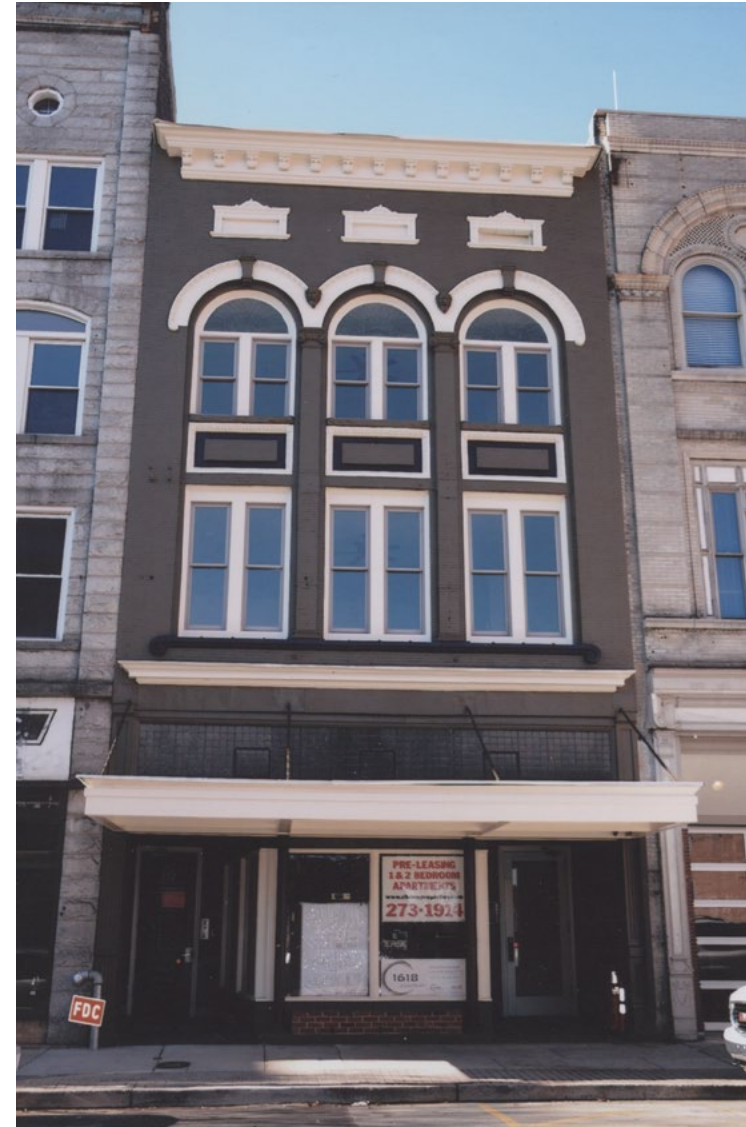
[22] **Not Recommended:** (a-b) The original wood windows in this late-19<sup>th</sup>-century building, which were highly decorative, could likely have been repaired and retained. (c) Instead, they were replaced with new windows that do not match the detailing of the historic windows and, therefore, do not meet the Standards (above).

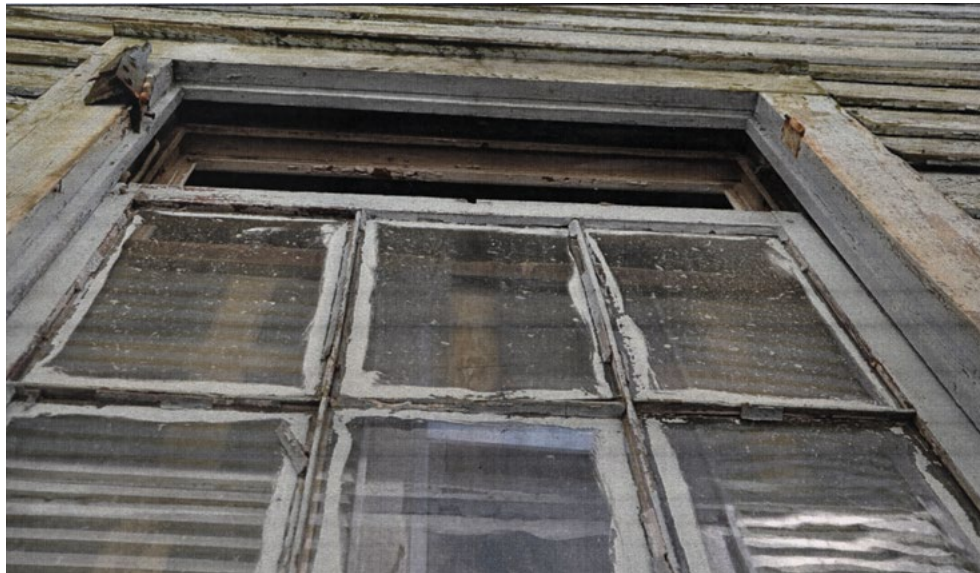
[23] (a) This deteriorated historic wood window was repaired and retained (b) in this rehabilitation project.

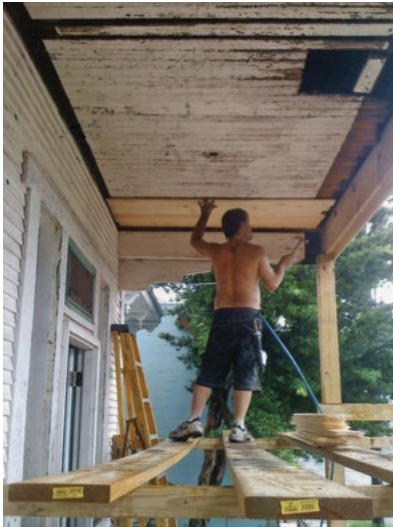
[24] Rotted boards in the beaded-board porch ceiling are being replaced with new matching beaded board.

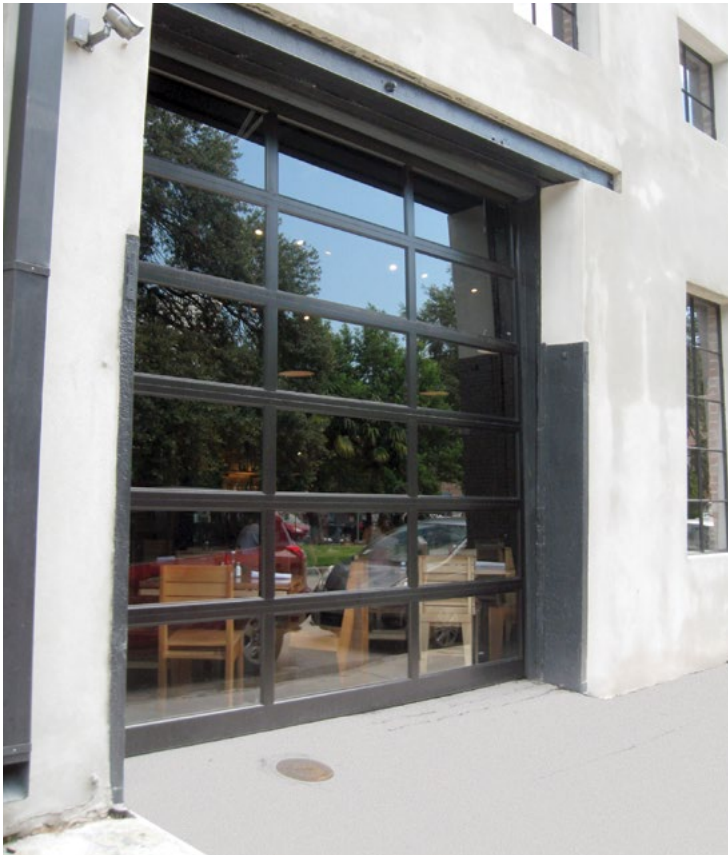
[25] The new infill designs for the garage door openings in this commercial building (a) converted for restaurant use and in this mill building (b) rehabilitated for residential use are compatible with the historic character of the buildings.

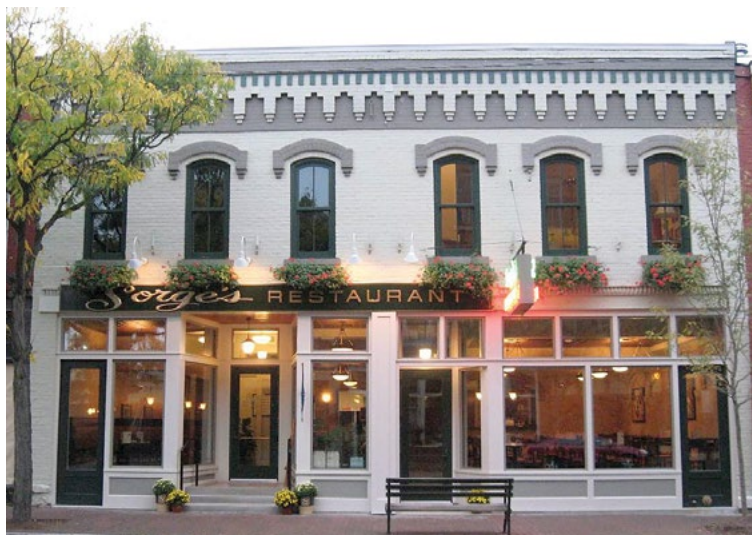
[28] This new storefront, which replaced one that was missing, is compatible with the historic character of the building.

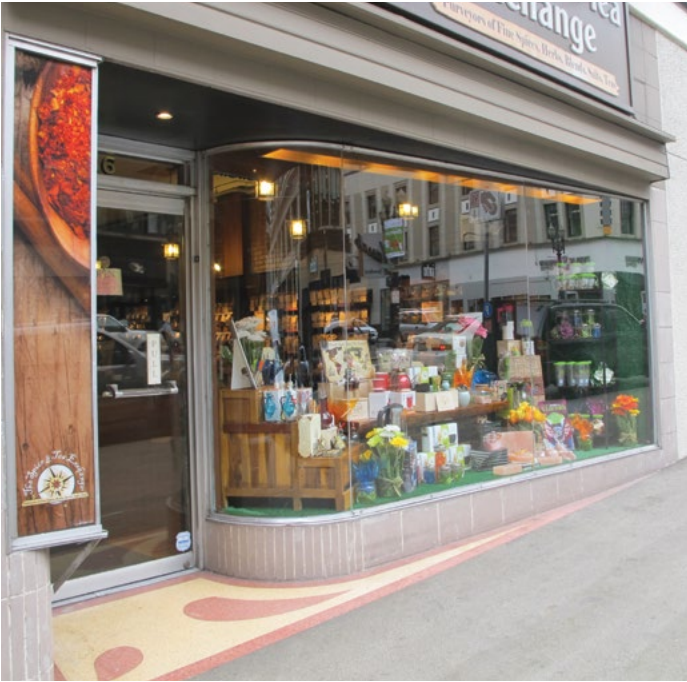
[27] This original c. 1940s storefront, with its character-defining angled and curved glass display window and recessed entrance with a decorative terrazzo paving, is in good condition and should be retained in a rehabilitation project.

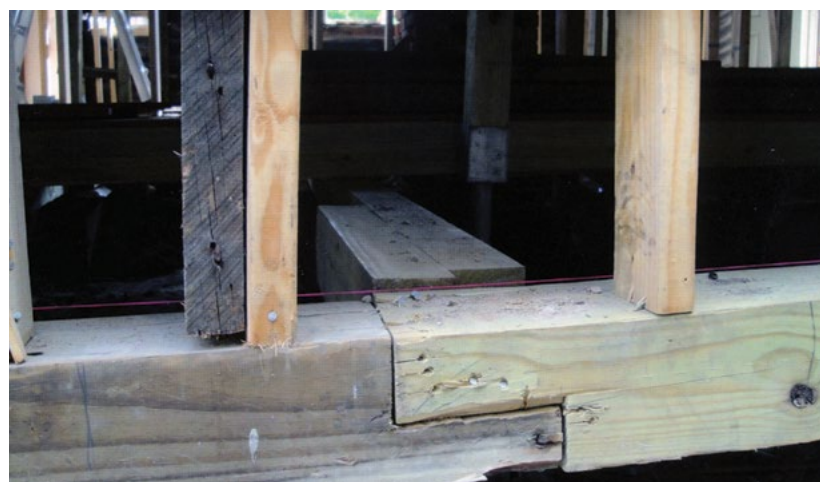
[33] Retaining as much as possible of the historic wood sill plate and replacing only the termite-damaged wood is always the preferred and recommended treatment.

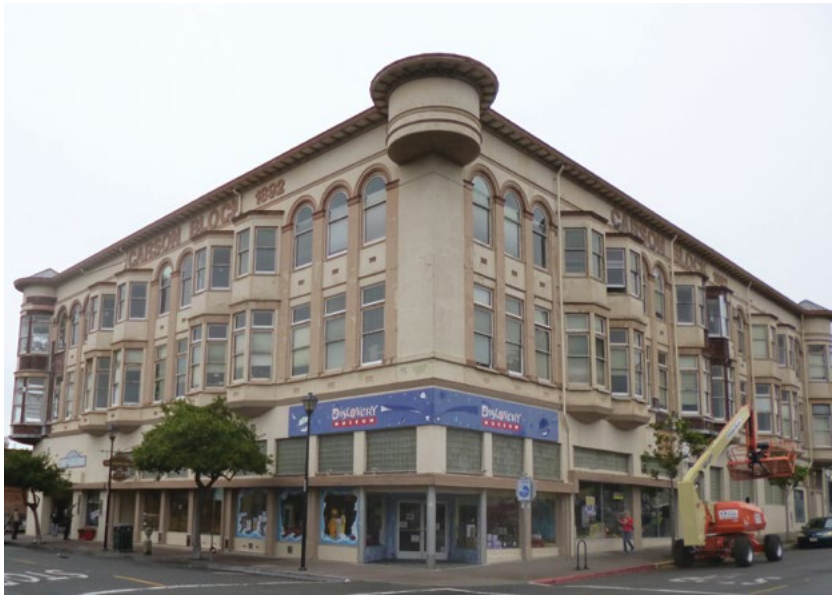
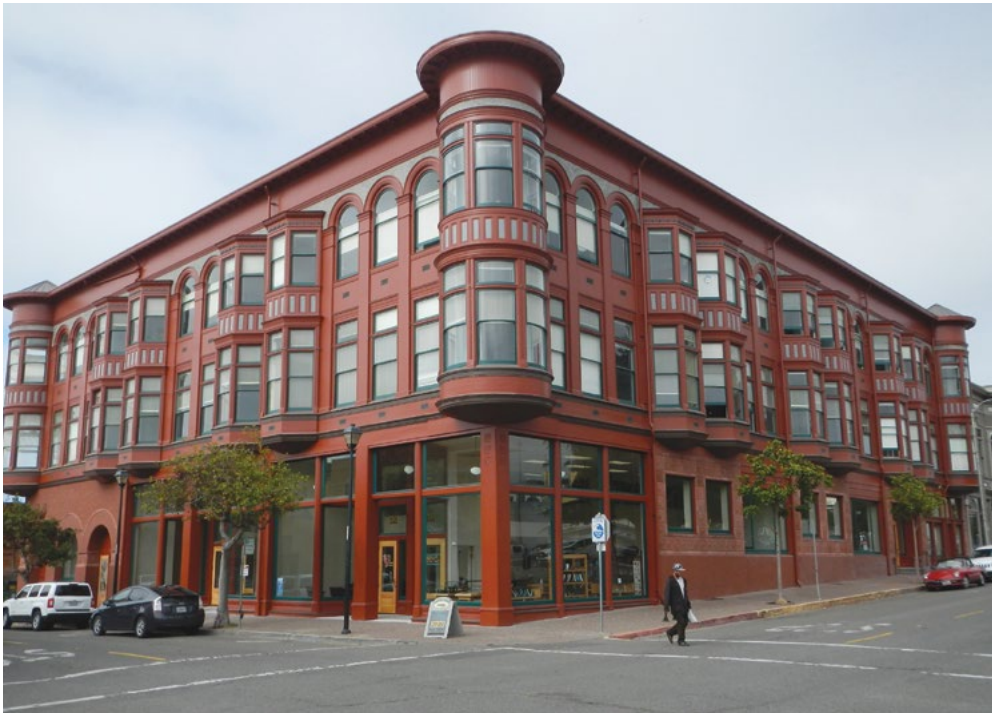
[32] (a-b) The rehabilitation of the 1892 Carson Block Building in Eureka, CA, for its owner, the Northern California Indian Development Council, included recreating the missing corner turret and sensitively introducing seismic reinforcement (c) shown here (opposite page) in a secondary upper floor office space. Photos: Page & Turnbull.

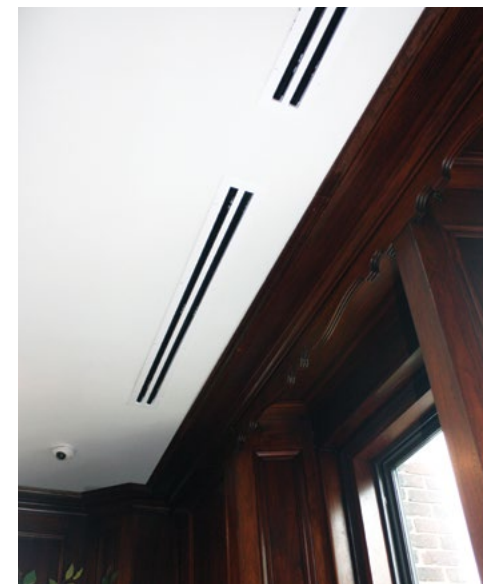
[34] The new ceiling ducts installed during the conversion of this historic office building into apartments are minimal in design and discretely placed above the windows.

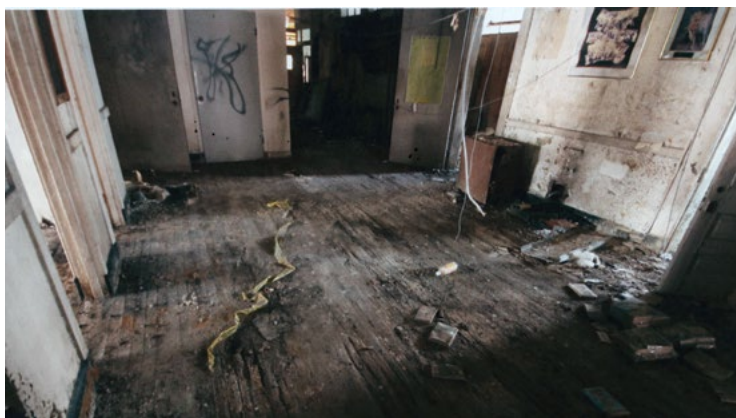
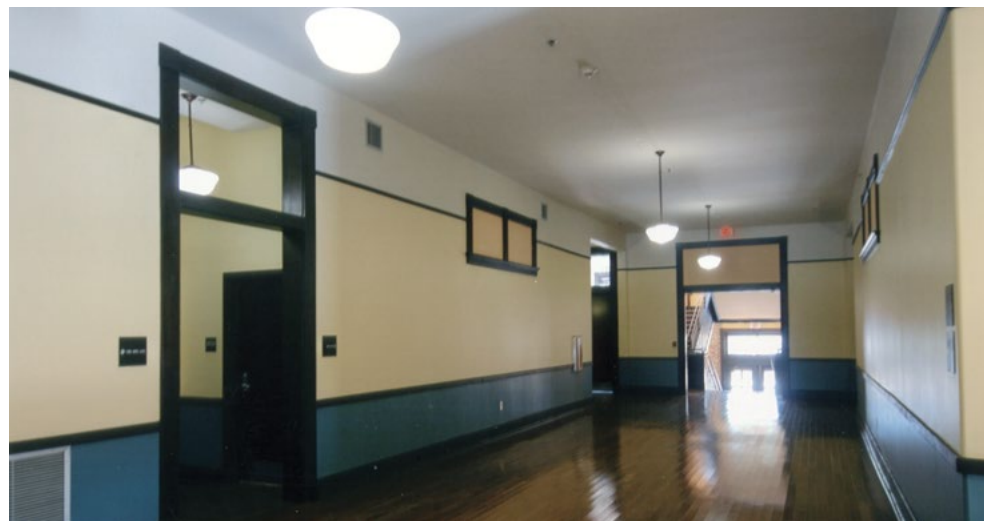
[35] (a) Although deteriorated, the historic school corridor, shown on the left, with its character-defining features, including doors and transoms, was retained and repaired as part of the rehabilitation project (b).

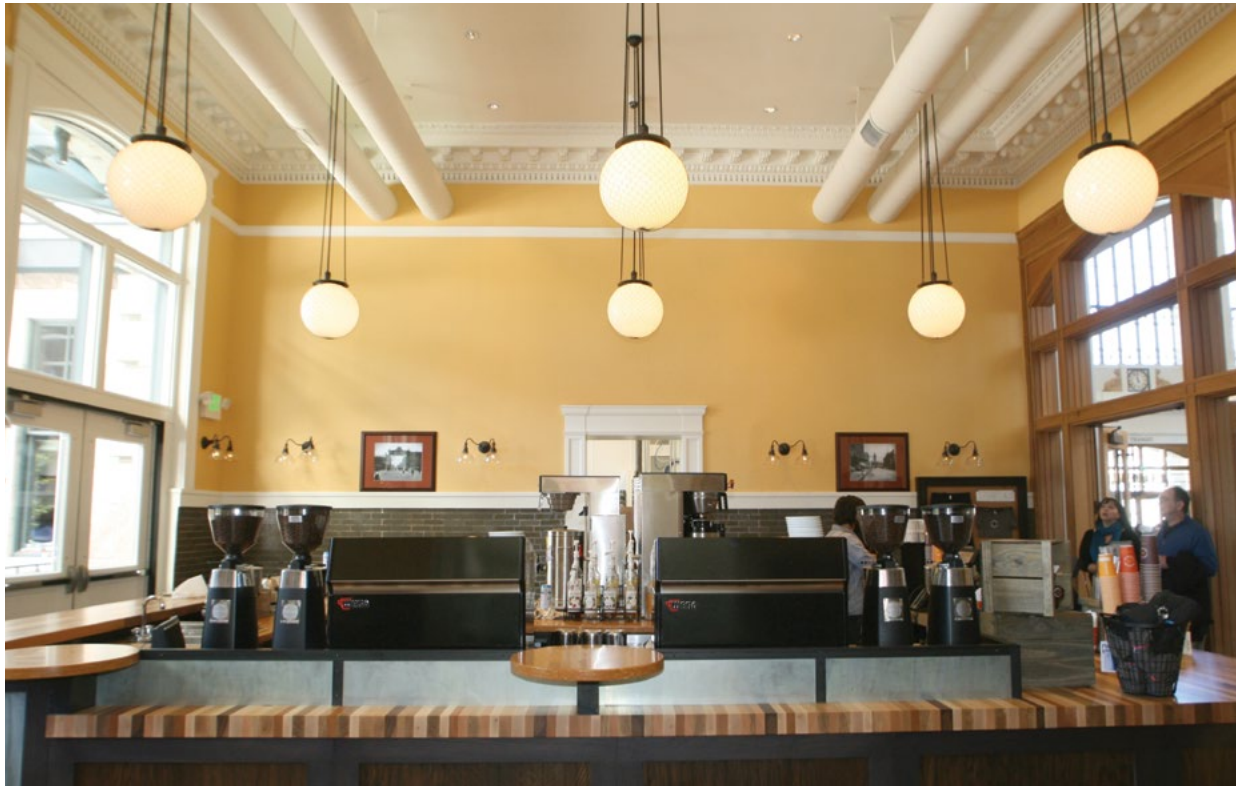
[37] Exposed and painted ducts were appropriately installed here in a retail space in Denver's historic Union Station after considering other options that would have impacted the ceiling height, or damaged or obscured the ornamental plaster crown molding. Photo: Heritage Consulting Group.

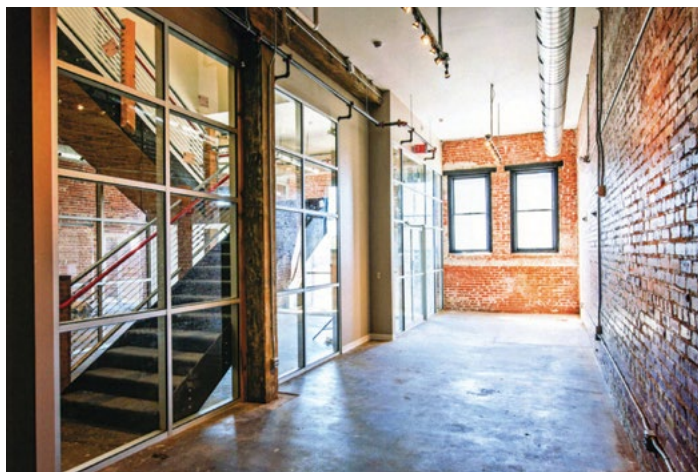
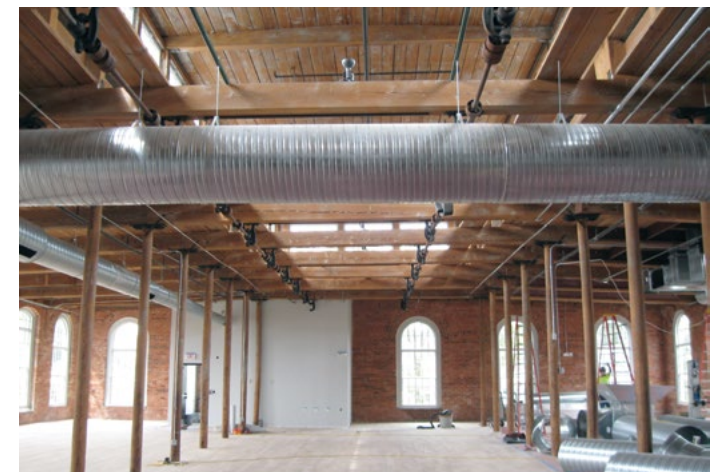
[39] Leaving the ceiling structure exposed and installing exposed ductwork where it does not impact the windows, are appropriate treatments when rehabilitating an industrial building for another use.

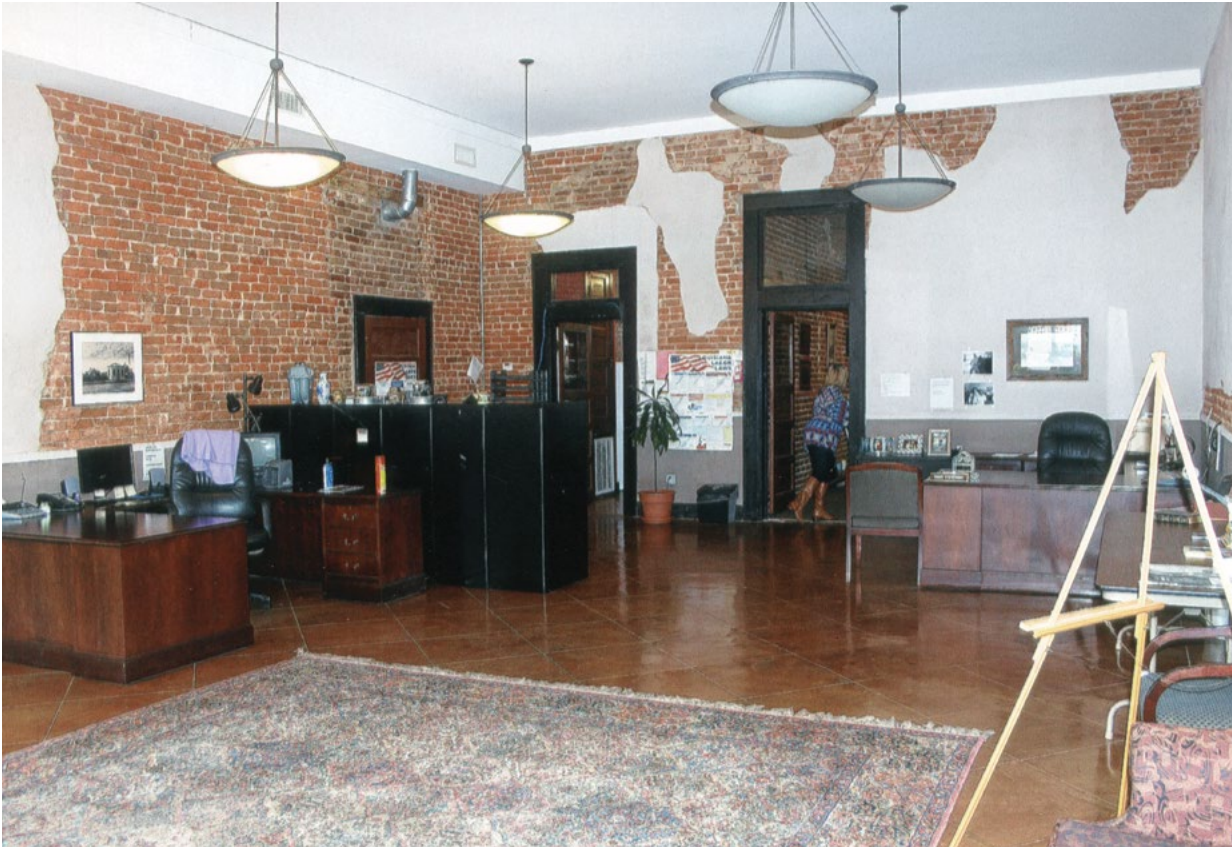
[41] **Not Recommended:**  
Leaving fragments of deteriorated or "sculpted" plaster is not a compatible treatment for either finished or unfinished interior spaces.

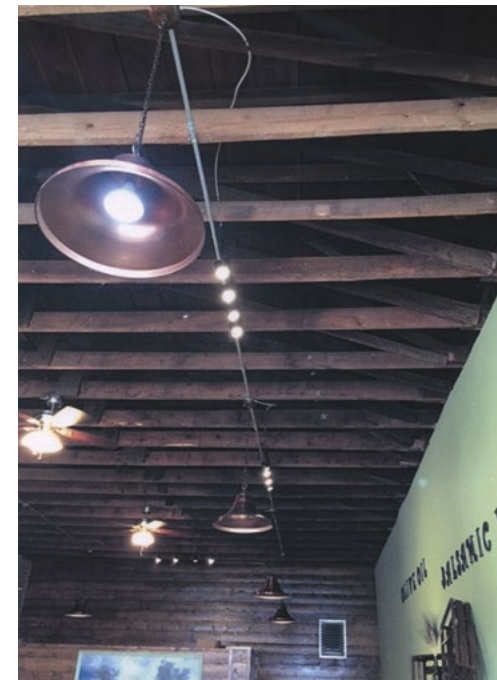
[40] **Not Recommended:**  
Removing a finished ceiling and leaving the structure exposed in a historic retail space does not meet the Standards for Rehabilitation.

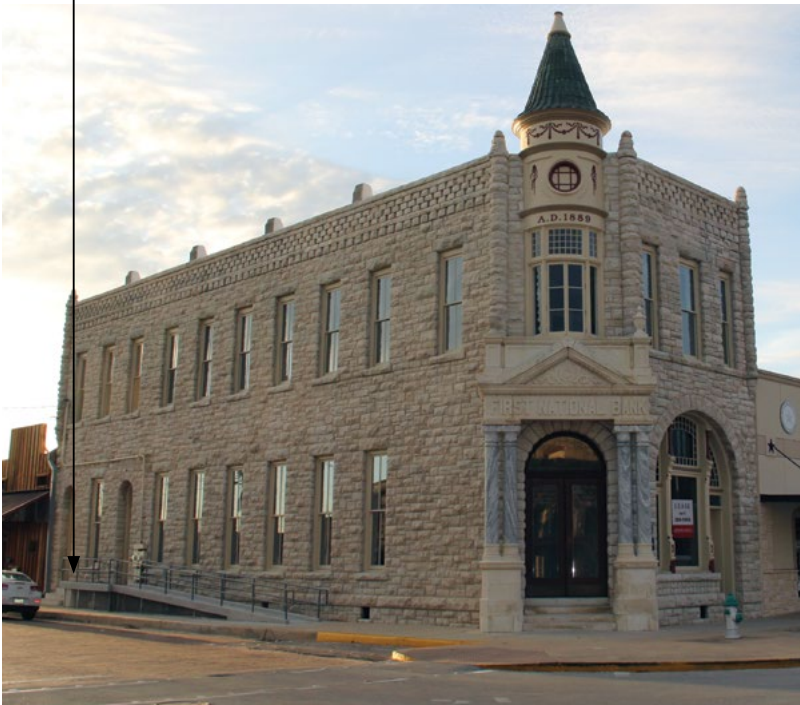
[53] This entrance ramp (right) is compatible with the historic character of this commercial building.

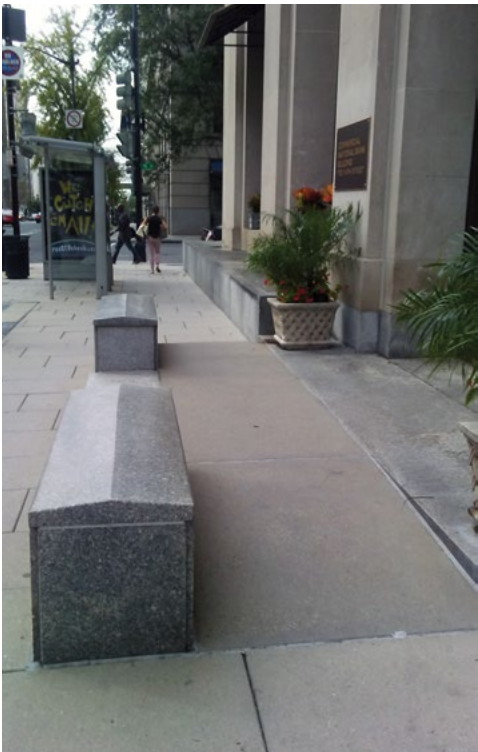
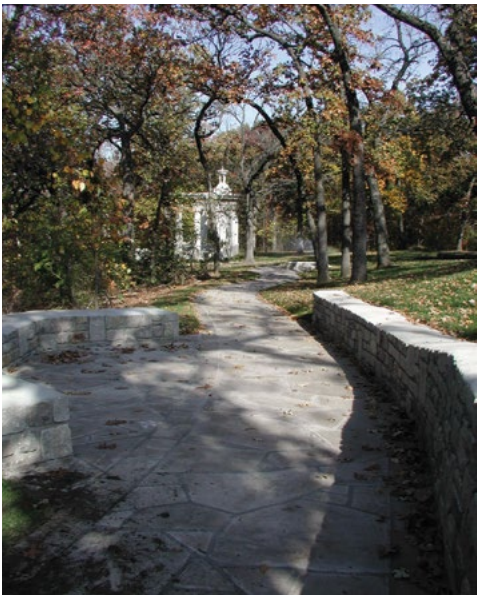
[54] The gently-sloped path in a historic park in Kansas City, MO, which accesses the memorial below, includes a rest area part way up the hill. Photo: STRATA Architecture + Preservation.

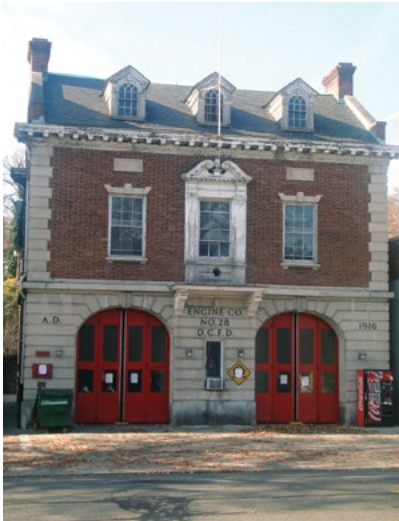
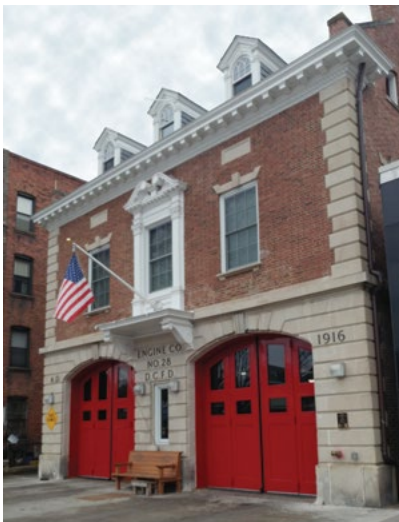
[56 a-b] In order to continue in its historic use, the door openings of this 1916 Colonial Revival-style fire station had to be widened to accommodate the larger size of modern fire trucks. Although this resulted in some change to the arched door surrounds, it is minimal and does not negatively impact the historic character of the building. (a) Above, before; Photo: Fire and Emergency Medical Services Department (FEMS), Washington, D.C.; below, after.
