**Historic Preservation Board Agenda  
Regular Meeting\***  
**Virtual Meeting via GoToMeeting**  
**Thursday, April 1, 2021 – 6:15 P.M.**  
*(Order & Contents Subject to Change by Action of the Historic Board)*

**CONSIDER AN APPLICATION FOR RESCISSION OF LOCAL HISTORIC DESIGNATION OF THE SEYMOUR AND BIRDIE RHODE HOUSE LOCATED AT 149 DENVER AVENUE AND PROVIDE A RECOMMENDATION TO THE FORT LUPTON CITY COUNCIL**

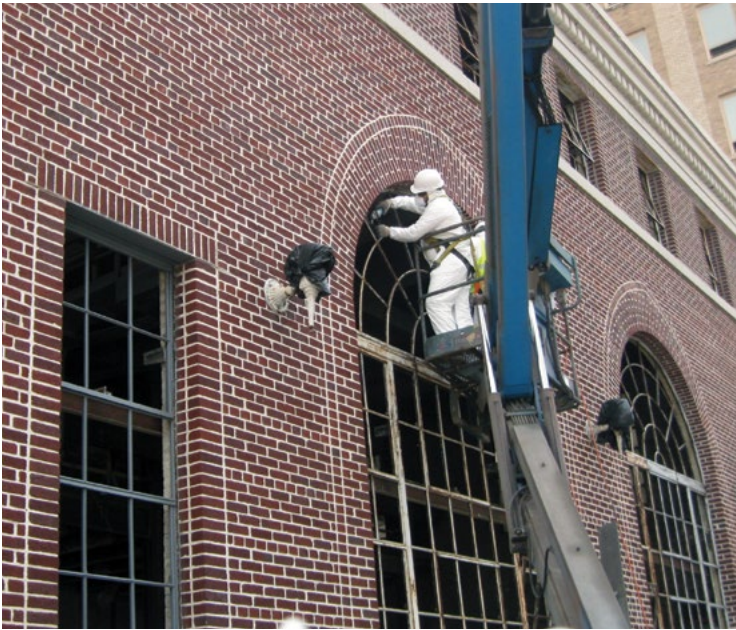
[57] Workers wear protective clothing while removing lead paint from metal features.

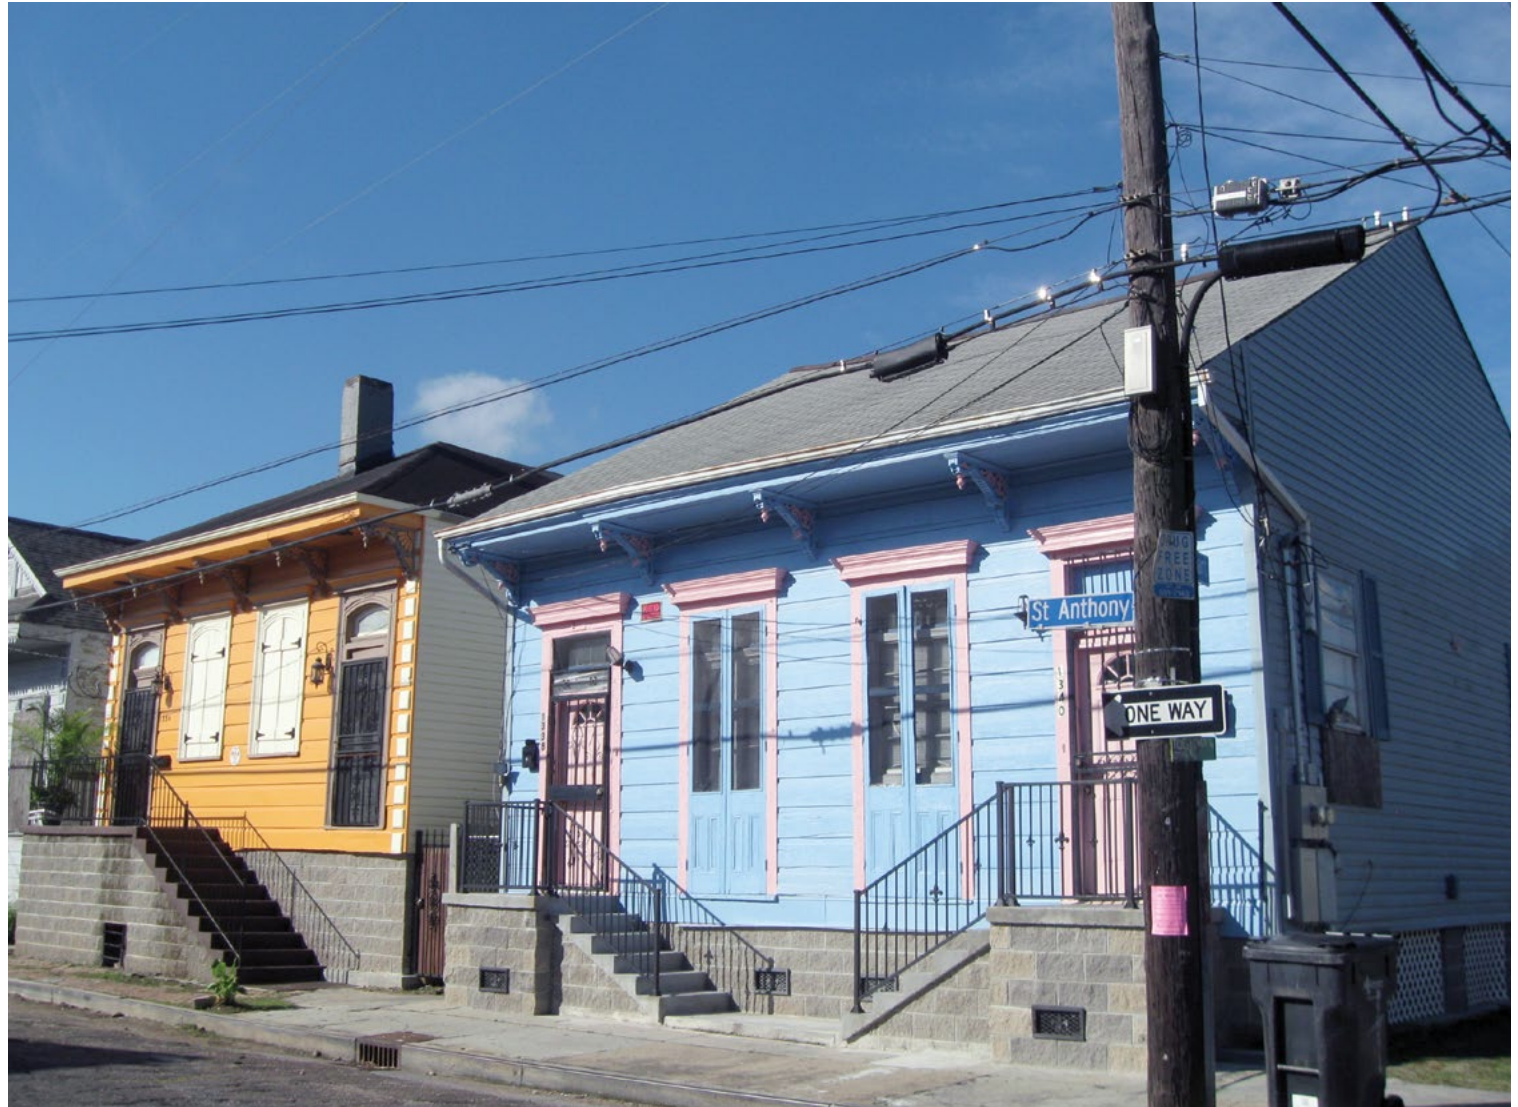
[60] In some instances, it may be necessary to elevate a historic building located in a floodplain to protect it. But this treatment is appropriate only if elevating the building will retain its historic character, including its relationship to the site, and its new height will be compatible with surrounding buildings if in a historic district. The house on the right, which has been raised only slightly, has retained its historic character. The house on the left has been raised several feet higher, resulting in a greater impact on the historic character of the house and the district.

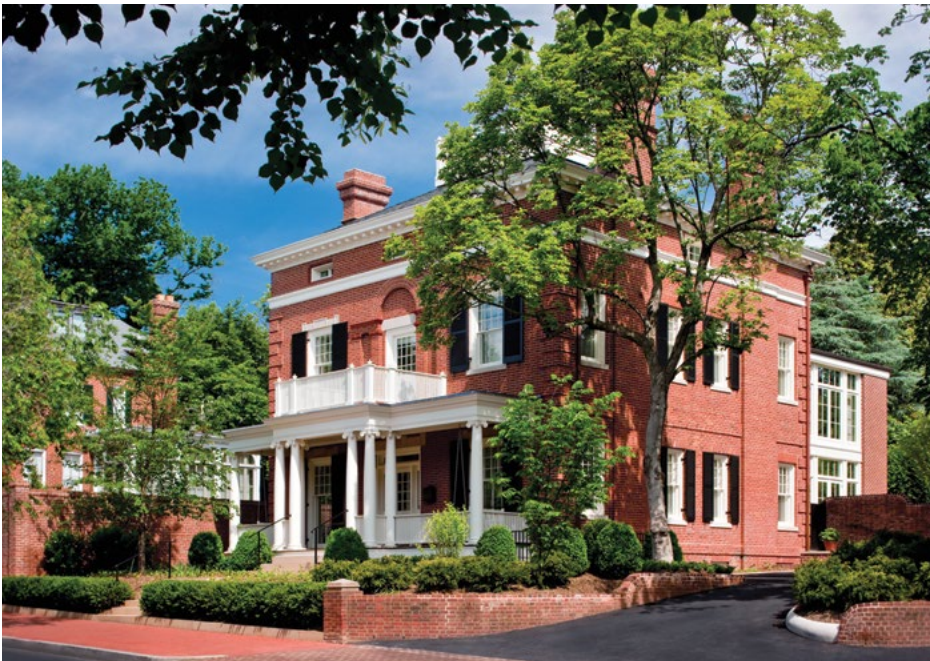
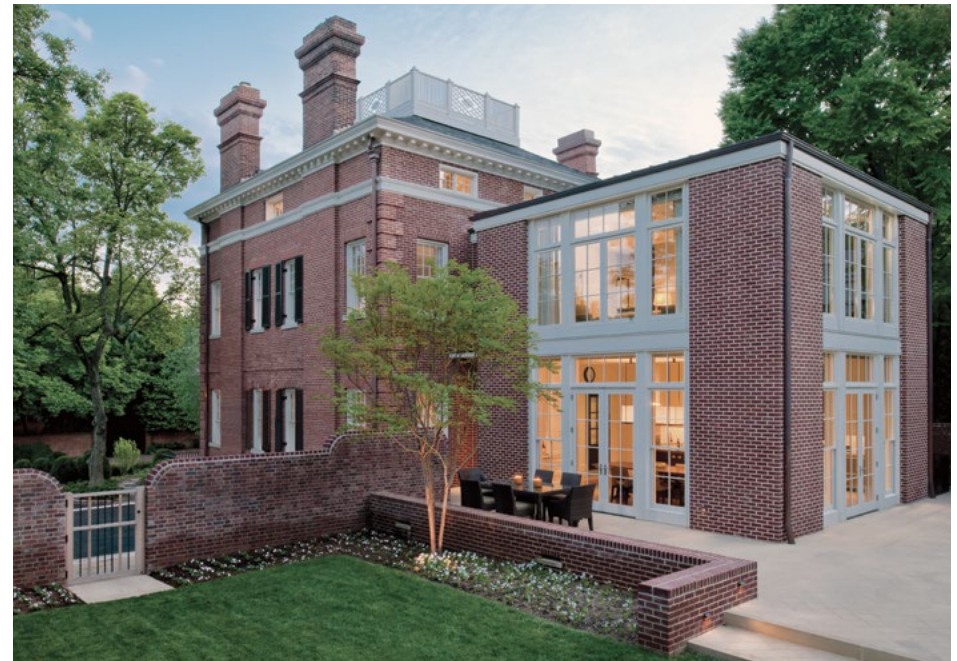
[61 a-b] The materials, design, and location at the back of the historic house are important factors in making this a compatible new addition. Photos: © Maxwell MacKenzie.

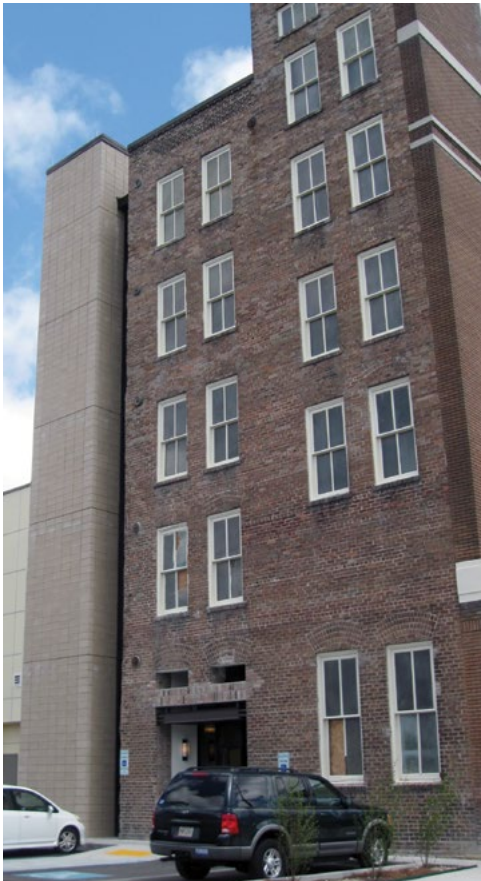
[62] The stair tower at the rear of this commercial building is a compatible new addition.

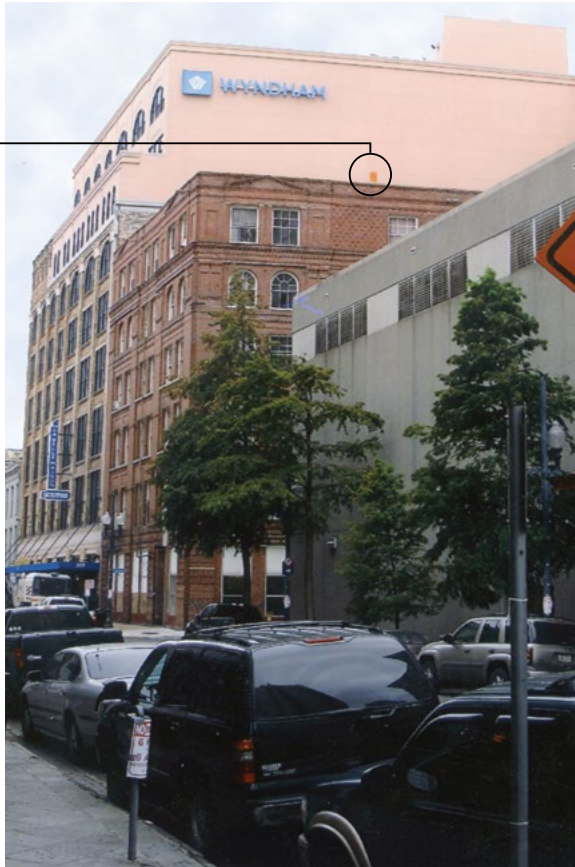
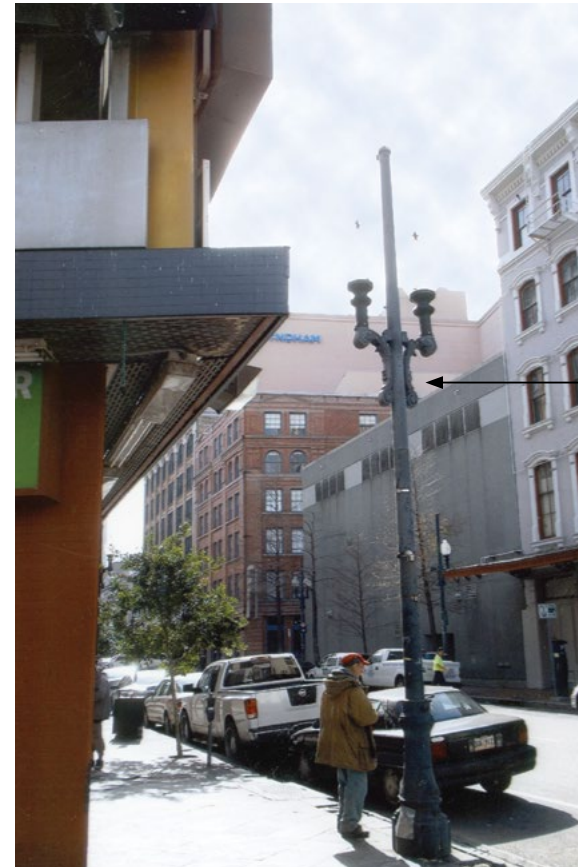
[ 63] (a) A mockup should be erected to demonstrate the visibility of a proposed rooftop addition and its potential impact on the historic building. Based on review of this mockup (orange marker), it was determined that the rooftop addition would meet the Standards (b). The addition is unobtrusive and blends in with the building behind it.

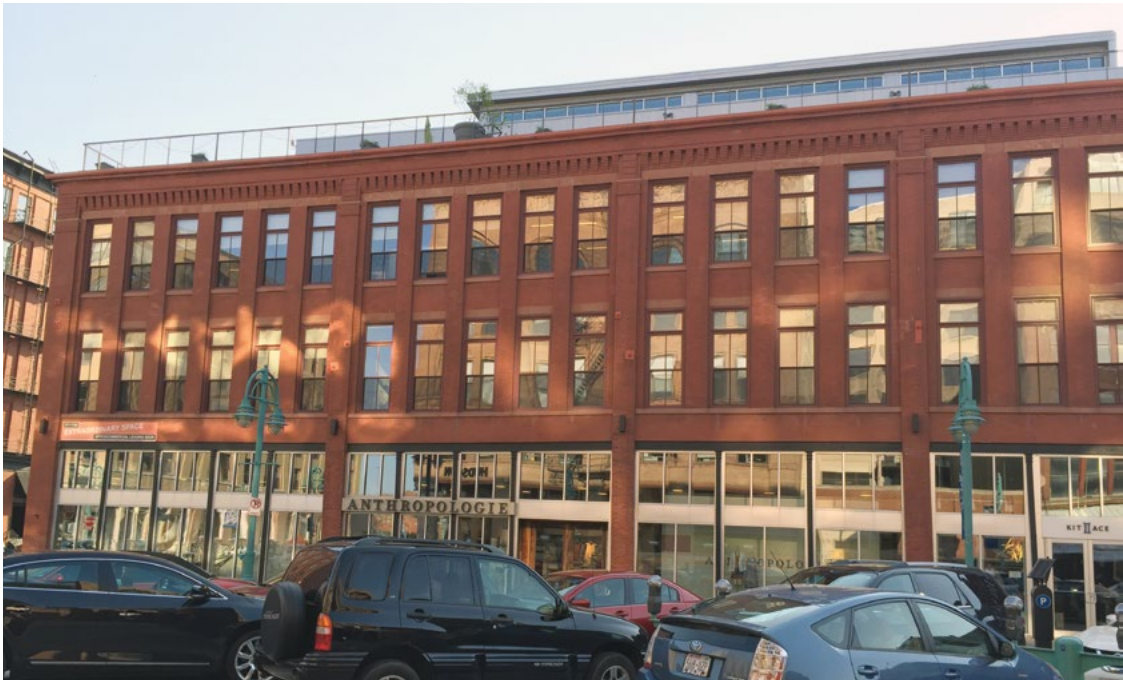
[64] **Not Recommended:**  
It is generally not appropriate to construct a rooftop addition on a low-rise, two- to three-story building such as this, because it negatively affects its historic character.

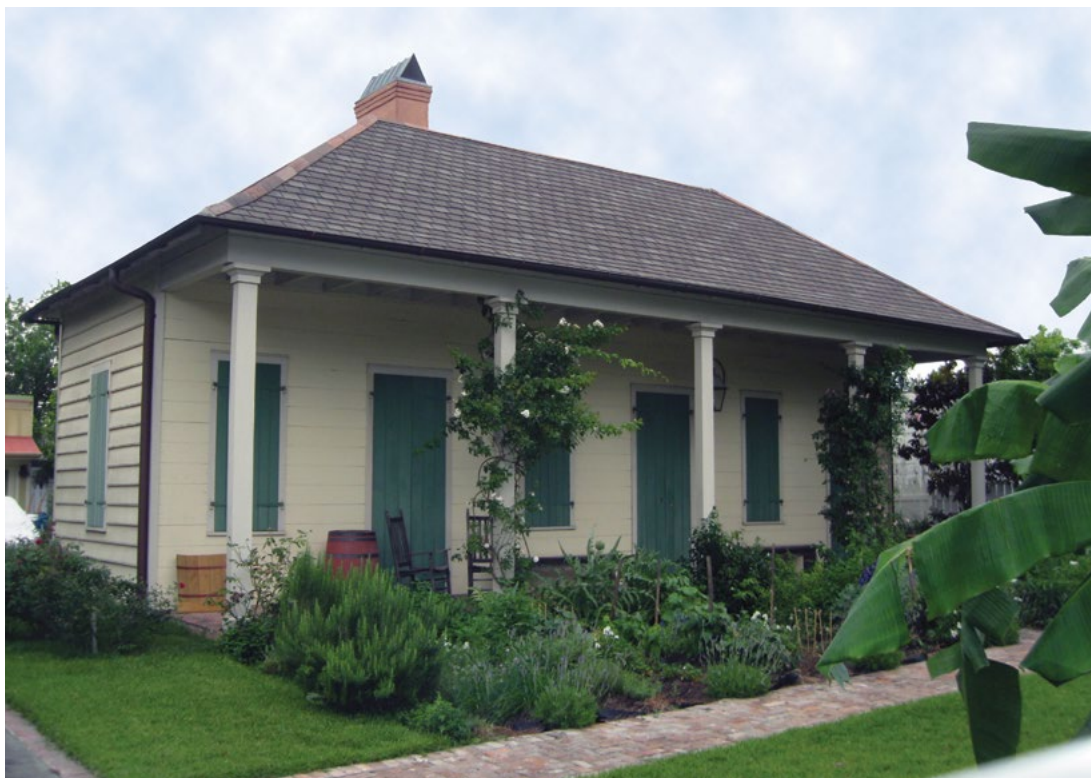
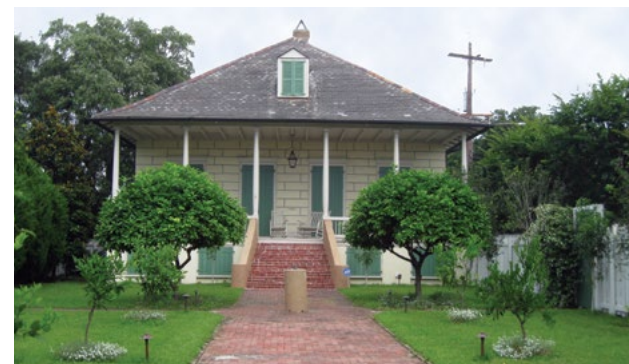
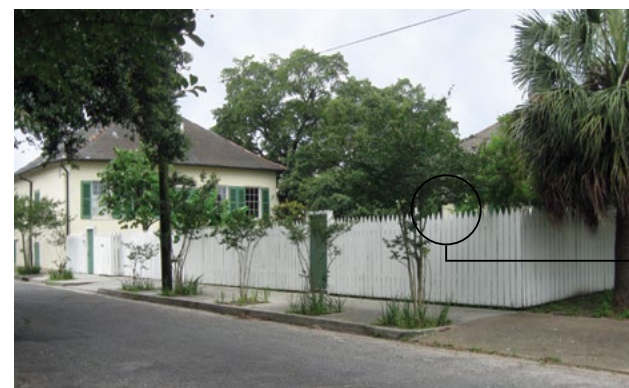
[65] (a) This (far left) is a compatible new outbuilding constructed on the site of a historic plantation house (b). Although traditional in design, it is built of wood to differentiate it from the historic house (which is scored stucco) located at the back of the site so as not to impact the historic house, and minimally visible from the public right-of-way (c).
