## Historic Preservation Board

**APPROVE A REQUEST FOR REPORT OF ACCEPTABILITY FOR THE SEYMOUR AND BIRDIE RHODE HOUSE (149 DENVER AVENUE) FOR A PATIO COVER**

**Architectural Inventory Form**

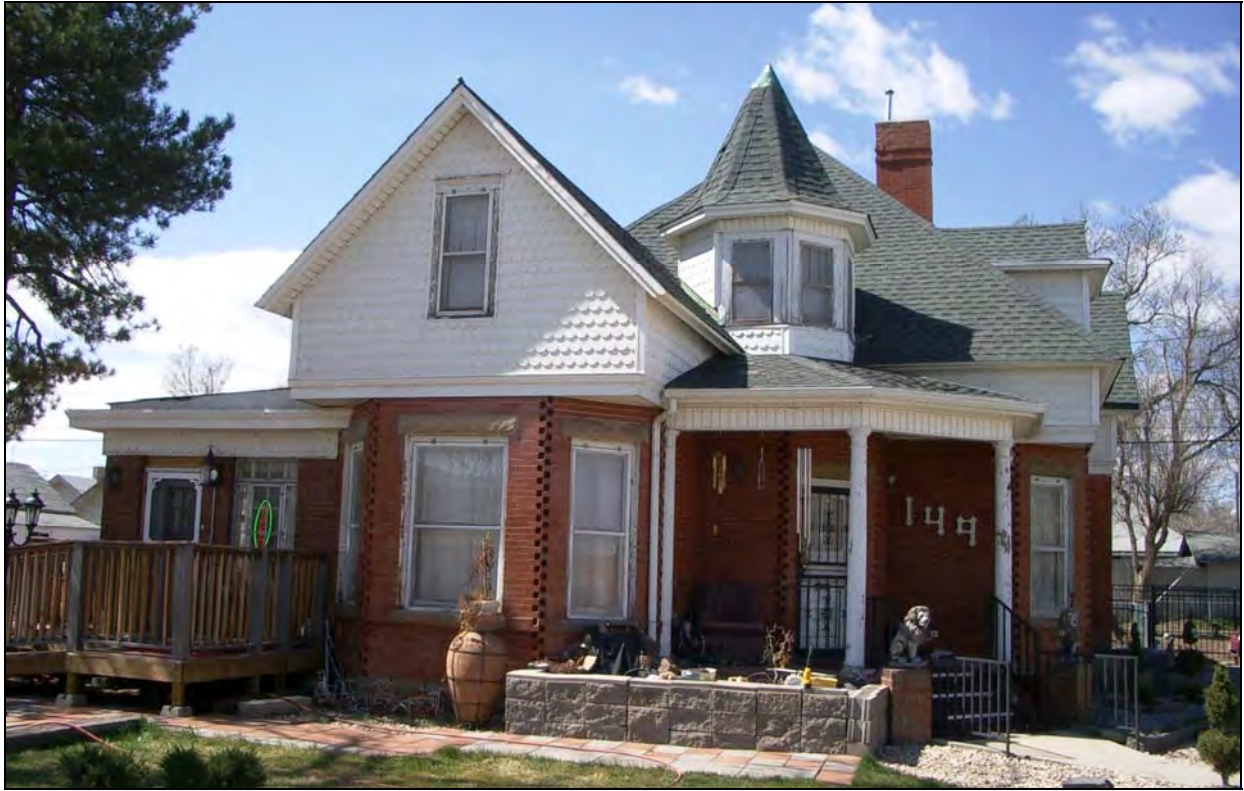
View of the east elevation of the Rhode House. View to the west.

20. Special Features (enter all that apply): **Porch, Dormer, Decorative Shingles, Chimney, Tower, Attached Garage**
21. General Architectural Description: **This corner lot contains a 1-1/2 story masonry residence that faces toward the east. Centered on the property, the home rests upon what appears to be a concrete foundation with stone facing above grade. The building's first floor exterior walls are constructed of brickwork laid in common bond coursing. Fishscale shingles clad the short upper story walls. The home's front entrance, with a wood panel door and metal storm door, is found on its northeast cutaway corner.**

**An open, three-sided porch projects from the home at this location. This porch, three steps up from the front sidewalk, consists of a masonry floor, open metal**

**rail, and a three-sided hipped roof supported by two wood columns and two engaged pilasters. Rising above the entrance and porch is a short wood frame octagonal tower. This tower has walls covered with fishscale shingles, three 3-over-1 double hung sash windows with wood frames, and a bell-cast octagonal roof with asphalt shingles and a tin cap.**

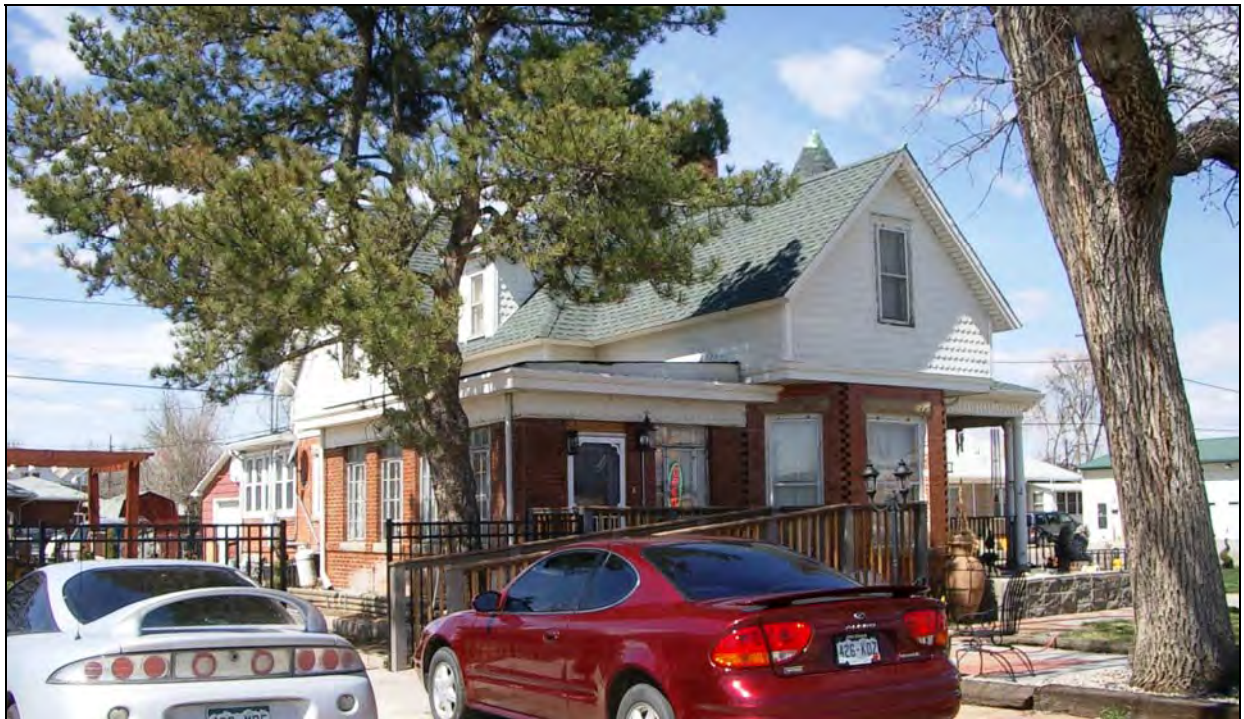
View of the south and east elevations. View to the northwest.

The building's southeast corner holds the entrance to a hair salon, reached by way of a small wood deck and handicap ramp. This entry has a wood panel door and storm door. Secondary entrances are found on the west and north elevations. The west elevation has a panel door and storm door that enter the rear enclosed porch. The northwest corner of the home has an overhead garage door (wood panel, 6 lights) providing access to a single-car attached garage.

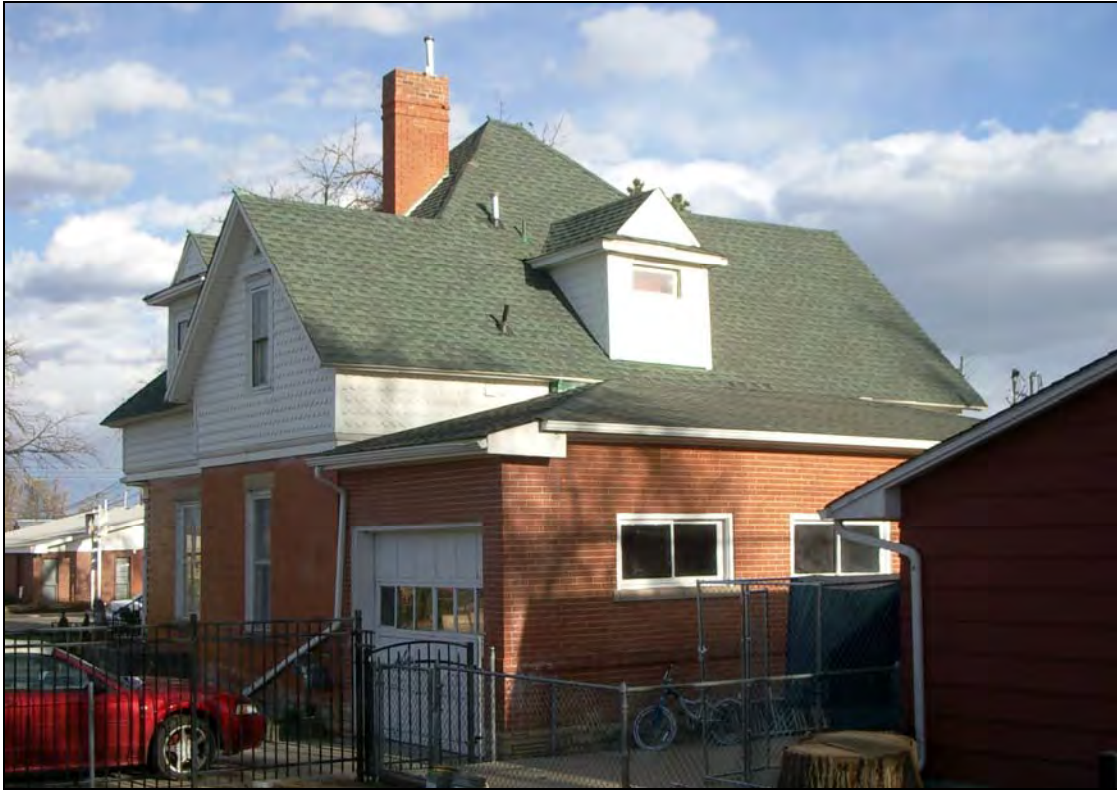
View of the north and west elevations. View to the southeast.

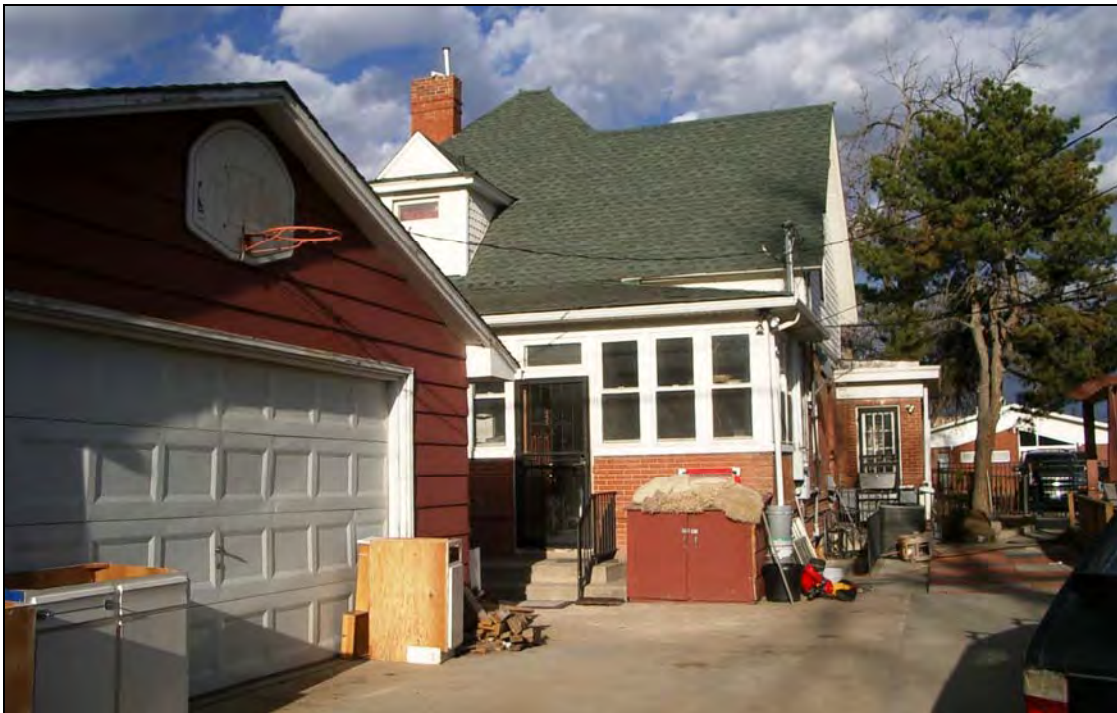
View of the southwest corner of the house and the new garage. View to the east.

**New Garage** - The new garage is located in the northwest quadrant of the property along the rear alley. This 24' x 24' wood frame building rests upon a concrete foundation and has walls finished with horizontal siding. It also has a gabled roof with asphalt shingles, a two-light sliding window on the north, and an overhead garage door on the south. The building was constructed in 1992 to serve as a two-car garage.

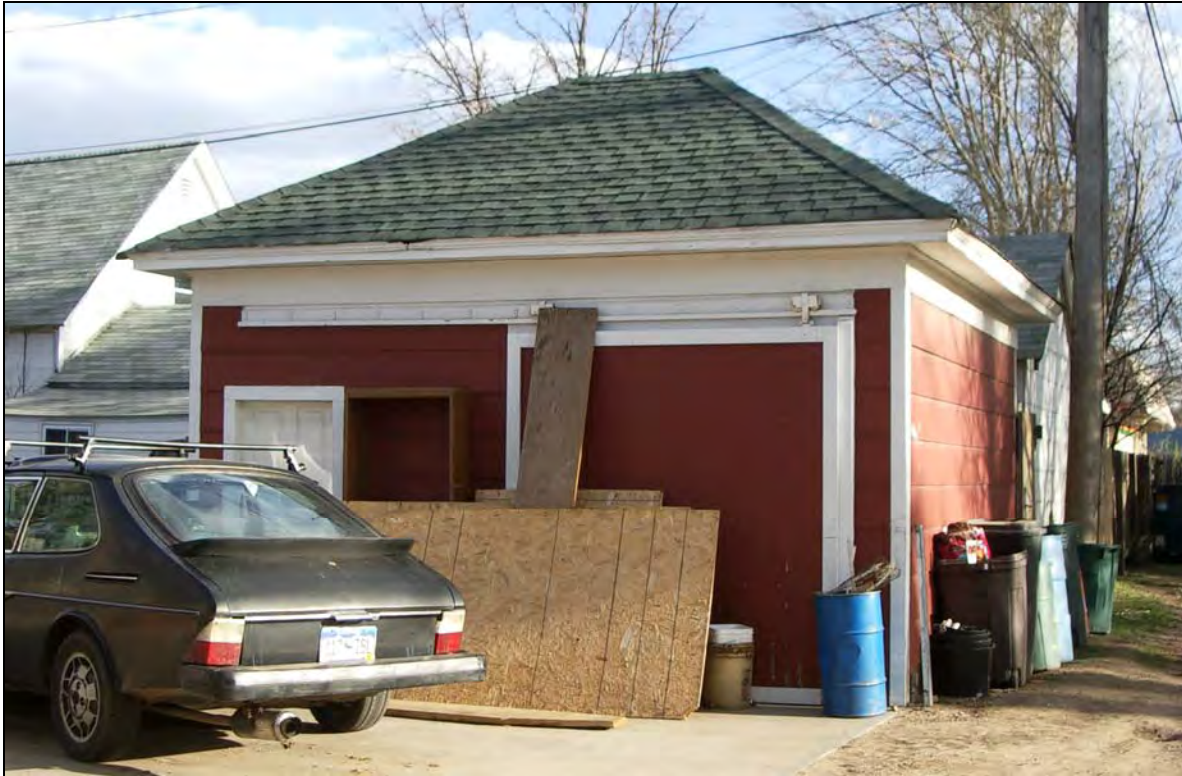
View of the old garage along the rear alley. View to the southeast

**Old Garage** - The old garage is located in the southwest corner of the property along the rear alley. This 14' x 16' wood frame building rests upon a concrete foundation and its exterior walls are finished with horizontal siding. It also has a hipped roof with asphalt shingles and a panel door and sliding wood garage door on the north elevation. The building was constructed sometime after 1936 to hold both a single auto and an adjoining shop or storage space.

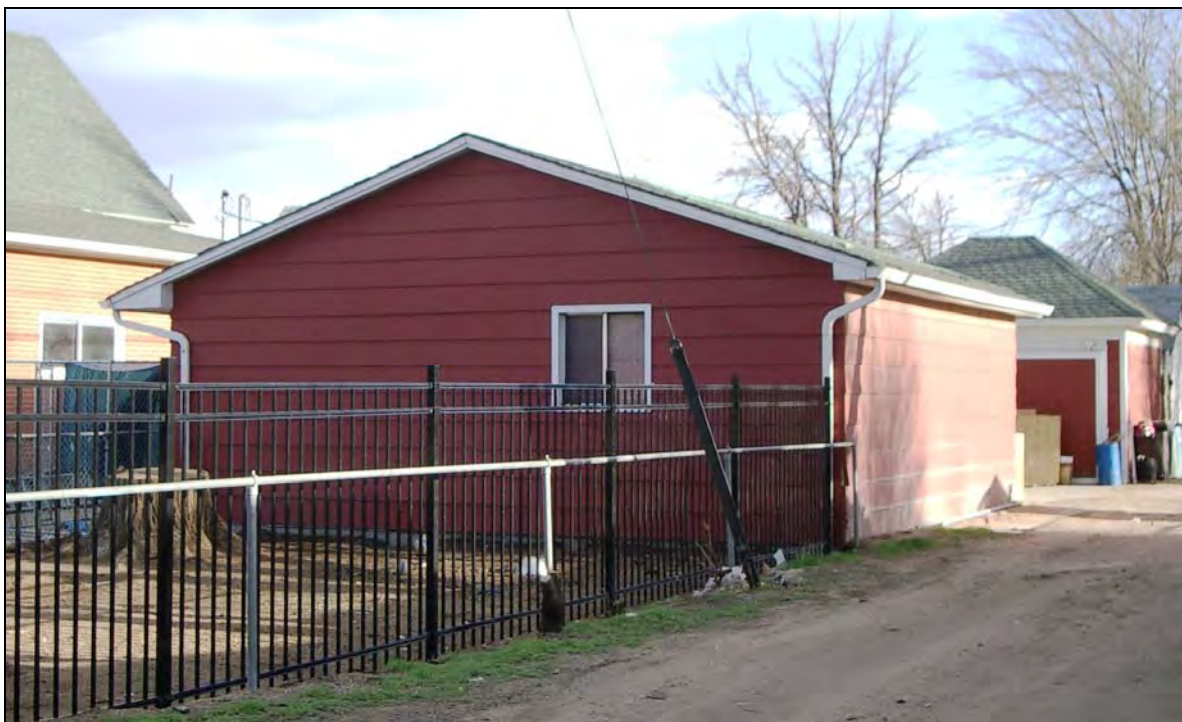
View of the new garage along the rear alley. View to the southeast.
